DIGITAL VNswitch 900 Series Modules
Versions 1.6.2 and 1.6.3
Release Notes
September 1997

As warranted, DIGITAL changes the firmware of this device to make functional enhancements or to correct reported problems. These release notes identify enhancements and changes to the firmware that impact end-user operations. They also contain firmware and software requirements, and list updates in this release as well as known conditions and restrictions that apply to the operation of the DIGITAL VNswitch 900EA, DIGITAL VNswitch 900 EE, DIGITAL VNswitch 900EF, DIGITAL VNswitch 900EX, and DIGITAL VNswitch 900XX modules.

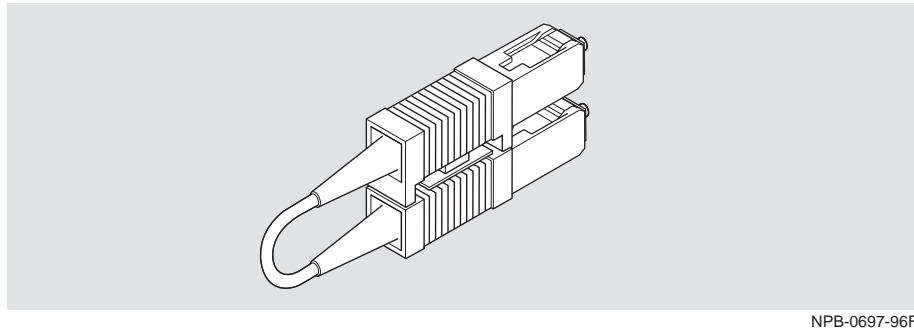
In Appendix C, the wrong connector is shown in Figure A-2: Multimode Fiber-Optic Loopback Connector. The correct figure follows:
