Memory Channel

Service Information

Order Number: EK-PCIMC-SV. A01

This information is for field service engineers. It includes maintenance and service information for PCI Memory Channel subsystems and instructions for removal and replacement of field-replaceable units (FRUs).

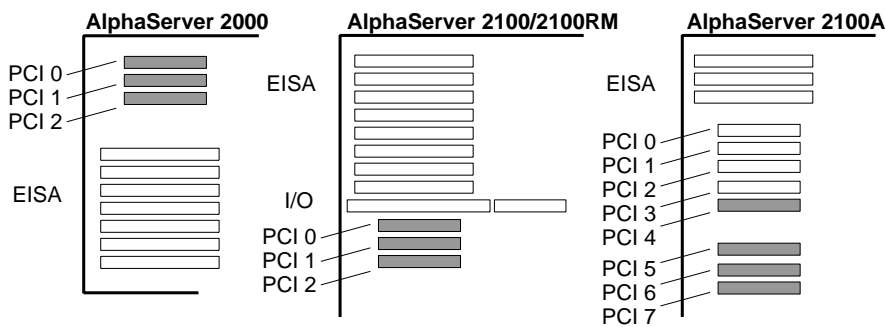
Figure 1-5 Bulkheads for AlphaServer 2000/2100/2100RM/2100A

Note that the DWLPA has a 256MB mapping register. Each CCMAB takes 128 MB of mapping register space, so if you install two CCMABs in a DWLPA, mapping register space will all be allocated.

- CCMAB adapter must be installed in one of the bottom four slots (see Figure 1-5). CCMAB adapters may not be installed in slots 0 through 3 or at power-up Memory Channel console error message #3 will result (see Section 2.3).

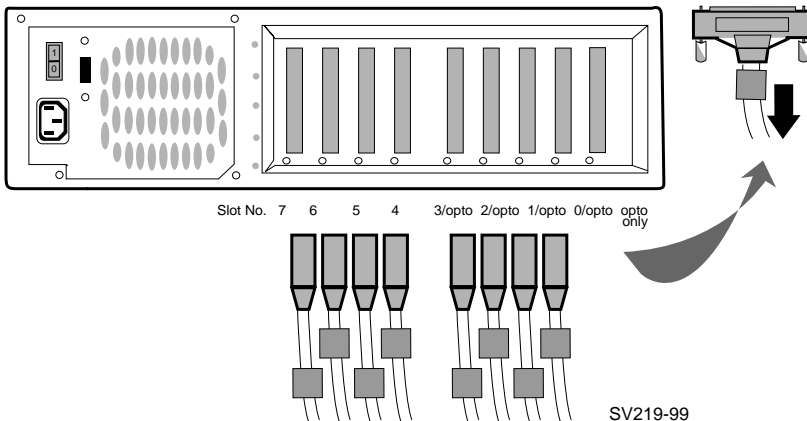
Figure 1-9 Cabling BN39B to the CCMHB Hub

One connector is always attached to a CCMAB adapter in a system. The second connector is attached to a CCMLB linecard in the hub (standard mode) or to another CCMAB adapter (virtual hub mode) in a second system. The ferrite sleeves of cables may interfere with each other. In this case, slide one or both sleeves slightly, keeping as close to the connectors as possible, until they fit (see Figure 1-9).

1. Loosen the embedded thumbscrews by turning counterclockwise.
2. Gently pull the cable connector from the receptacle on the back of the hub.

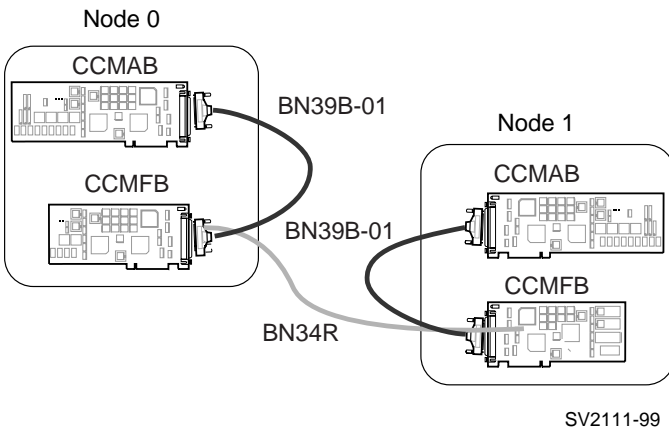
Figure 1-11 Virtual Hub with Fiber Optics Modules and Cable

A virtual hub configuration using fiber optics requires two CCMAB adapters, two CCMFB fiber optics modules, two BN39B-01 link cables, and one BN34R fiber optics cable.

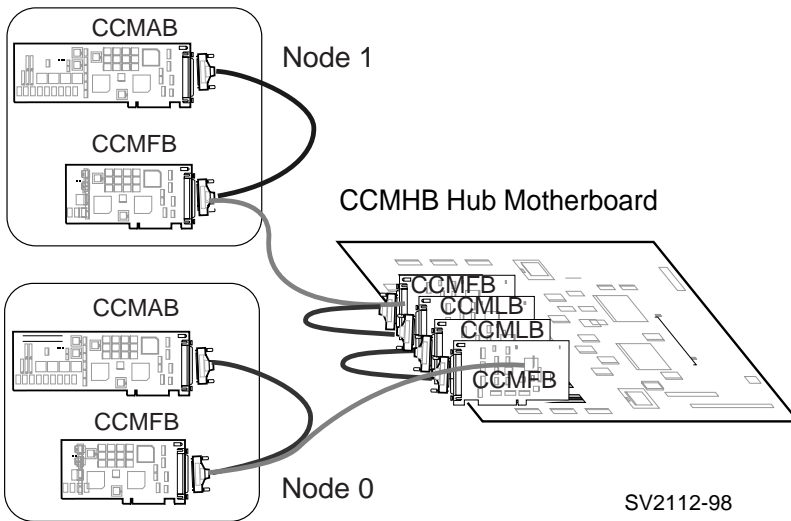
Figure 1-12 Standard Hub with Fiber Optics Modules and Cables

Each node in a standard hub configuration with fiber requires one CCMAB module, one CCMFB module, one BN39B-01 link cable, and one BN39R fiber optics cable. Each BN39R connects to a CCMFB in the CCMHB hub (Section 1.6), which in turn connects via a second BN39B-01 link cable to a CCMLB linecard (Section 1.8).

NOTE: CCMFB modules can only be installed in the first five hub slots: opto only, 0/opto, 1/opto, 2/opto, and 3/opto.

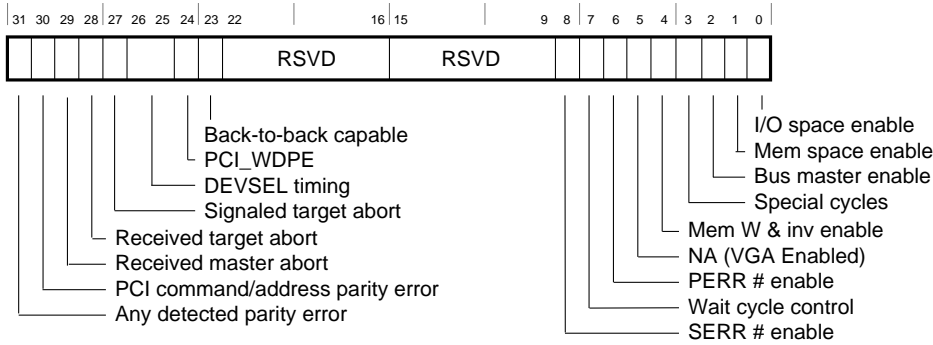
3.2.6 PCI Status and Control Register (CFG04H)

Table 3-1 PCI Status and Control Register (CFG04H) Bits

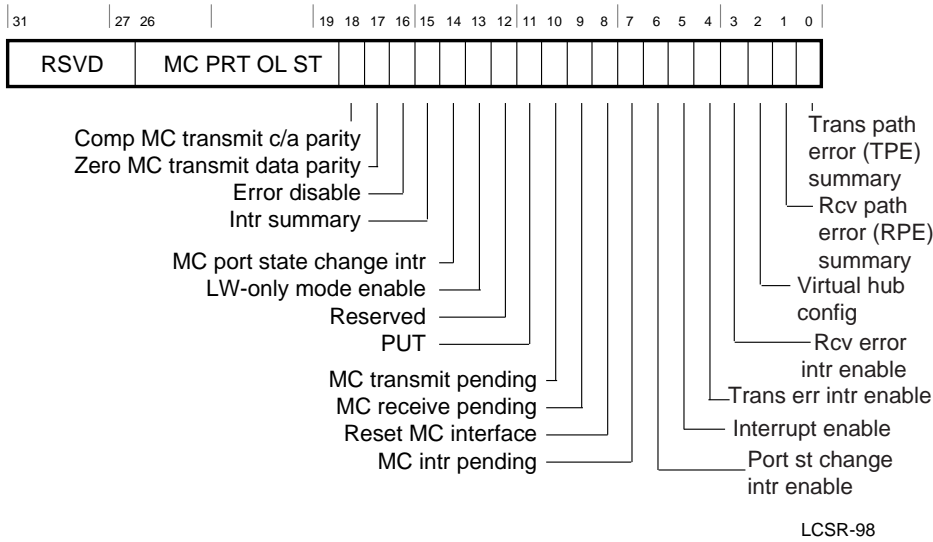
3.3.1 Link Control and Status Register (LCSR)

Table 3-3 LCSR Register (PTBAR + 40000) Bits

Name	Bit	Type	Description
RSVD	<31:27>	R, 0	Read as zeros.
MC Port Online State - Nodes [7:0]	<26:19>	R, 0	This field is a shadowed subset of the POS register. In hub-based systems, this field reflects the state of the MC port online state of all nodes in the cluster. A '1' indicates the port at the corresponding node ID is in the "Link Online" state; a '0' indicates it is not in the "Link Online" state. In virtual hub systems this field is undefined.
RSVD	<18:16>	R/W, 0	Reserved.
Interrupt Summary	<15>	R, 0	This bit represents the logical OR of all interrupting conditions from this adapter. TPE interrupt; RPE interrupt; MC interrupt and MC port state change interrupt.

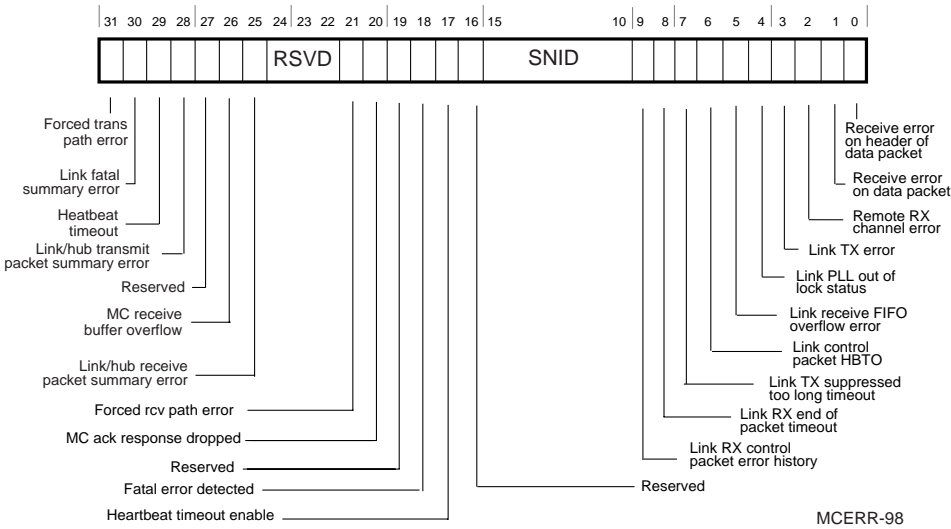
3.3.2 MC Error Register (MCERR)

Table 3-4 MCERR Register (PTBAR + 41000) Bits

Name	Bit(s)	Type	Description
RSVD	<31>	W1C, 0	Reserved.
Link Fatal Summary Error (Fatal)	<30>	W1C, 0	Set when the link generates either receive (RPE) or transmit (TPE) path fatal error. To determine the cause of this error, check MCERR bits <15:0>.
Heartbeat Timeout (HBTO)	<29>	W1C, 0	Set if the adapter detects a heartbeat timeout. Adapter sets this bit, TPE and RPE, goes to the Fatal Link Error State. The adapter's Link OK signal is deasserted and Link Online is then deasserted.
Link/Hub Trans Packet Summary Err	<28>	W1C, 0	Set when the link or hub detects a packet error on an MC Transmit Write. To determine the cause of this error, check MCERR bits <15:0>.
Reserved	<27>	R, 0	Reserved.
MC Receive Buffer Overflow	<26>	W1C, 0	Set if the adapter attempts to load the receive FIFO when the FIFO is full. Adapter sets this bit, TPE and RPE, goes to the fatal link error state, deasserts its Link OK signal; then deasserts Link Online.

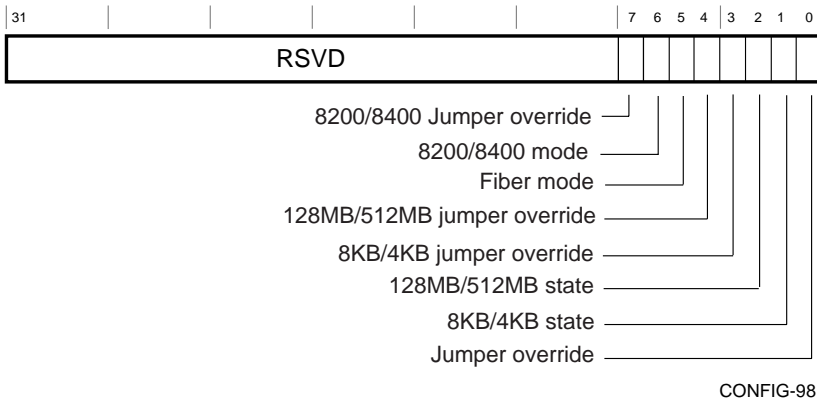
3.3.4 Module Configuration Register (MODCFG)

Table 3-6 Module Configuration Register (MODCFG) Bits

Name	Bits	Type	Description
RSVD	<31:8>	n, 0	Reserved.
8200/8400 Jumper Override	<7>	R/W, 0	When set, and the Jumper Override bit<0> is set, the adapter will be forced to 8200/8400 mode.
8200/8400 Mode	<6>	R, 0	When set, the adapter is in 8200/8400 mode, increasing 8200/8400 bandwidth up to 20MB/s.
Fiber Mode	<5>	R, 0	When set, the fiber mode jumper is installed and the module is in fiber mode.
128MB/512MB Jumper Override	<4>	R, 0	When set, and the Jumper Override bit<0> is set, the adapter window size will be 128MB. When set, and the Jumper Override bit<0> is cleared, the adapter window size will match the jumper.
8KB/4KB Jumper Override	<3>	R/W, 0	When set, and the Jumper Override bit<0> is set, the adapter page size will be 8KB. When set, and the Jumper Override bit<0> is cleared, the adapter page size will match the jumper.
128MB/512MB State	<2>	R, n	When set, the adapter will be mapped to a 128MB window. When cleared, the window is set to 512MB.

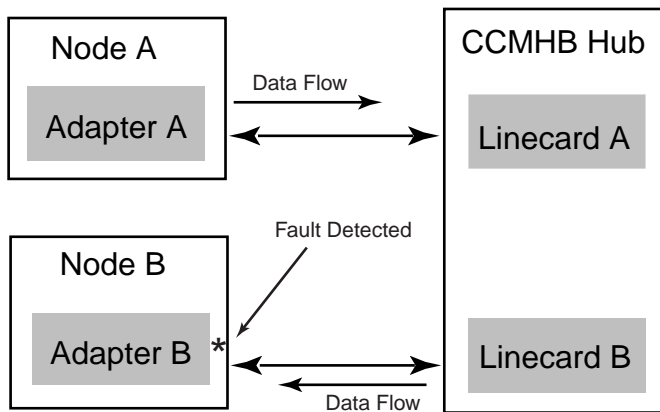
Figure 4-5 Two-Node Standard Hub Cluster - Case 3

Example 4-4 Link Detected “Receive Error on Data Packet” on Node B

Data Transfer: Node A transmits to Node B (see Figure 4-5)

Check/replace in suggested order:

- Cable/cable connections between linecard B and adapter A
- Adapter B
- Linecard B
- Linecard A
- Hub

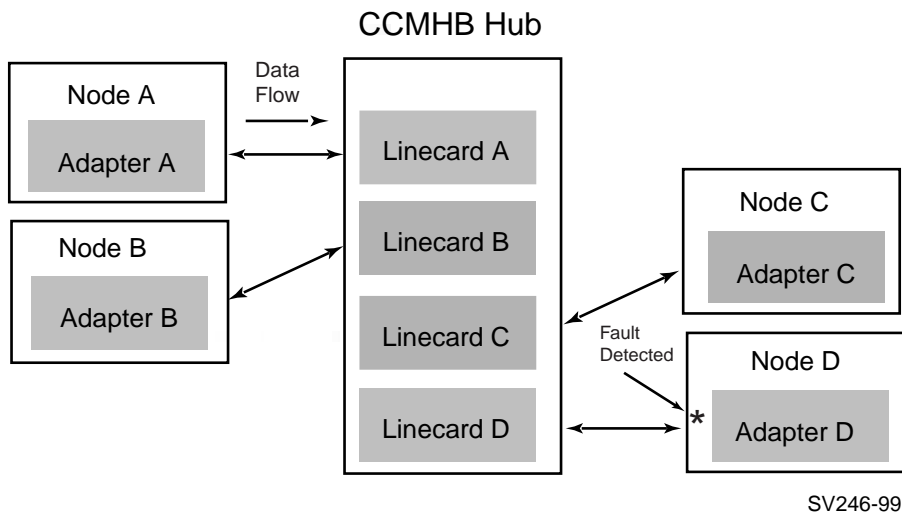
Figure 4-6 Four-Node Standard Hub Cluster - Case 1

Example 4-5 Link Detected "Receive Error on Data Packet" by Node D

Data Transfer: Node A transmits to ALL or ANY Node (see Figure 4-6)

Check/replace in suggested order:

- Cable/cable connections between linecard D and adapter D
- Adapter D
- Linecard D
- Linecard A - The SNID may have added value. Change linecard A before replacing the hub.
- Hub

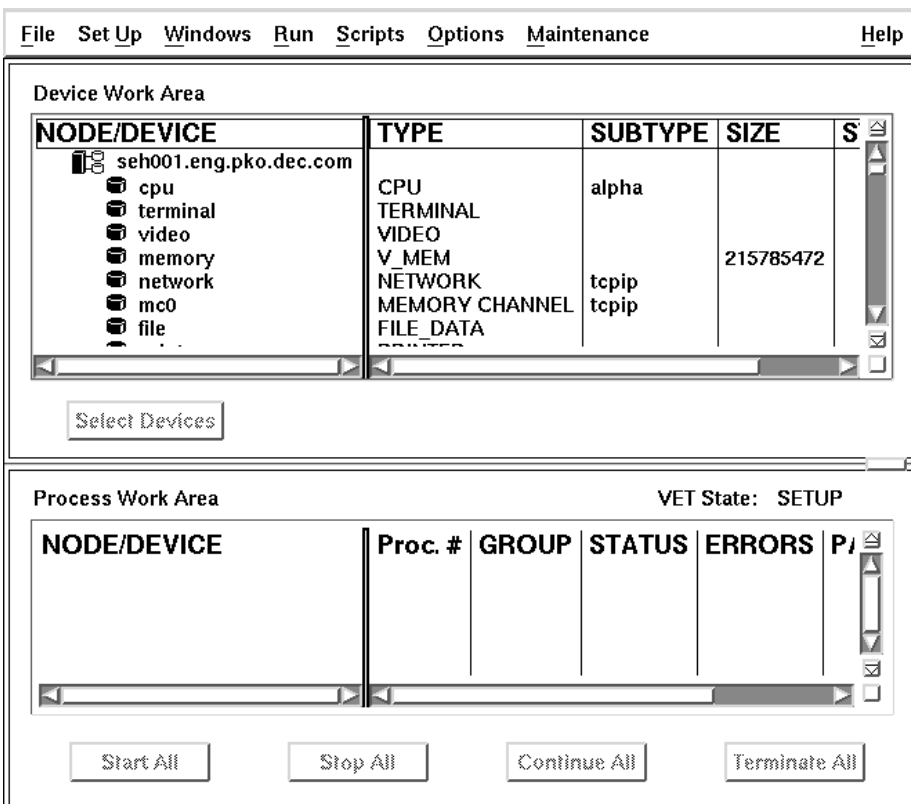
Figure B-1 Sized Device Screen

The Memory Channel exerciser provides on-line verification of the Memory Channel hardware. When the Verification Software is invoked, all nodes in a Memory Channel cluster that are visible to the operating system are automatically sized (see Figure A-1). The hub is not sized. All Memory Channel nodes will be displayed by the sizer according to device name (mc0, mc1, etc.) and will be identified as a Memory Channel device type. This information is listed by using the **show devices all** command.
