DEChub Network Products

Problem Solving

This book explains how to troubleshoot and correct problems that you may encounter with DEChub Networking products.

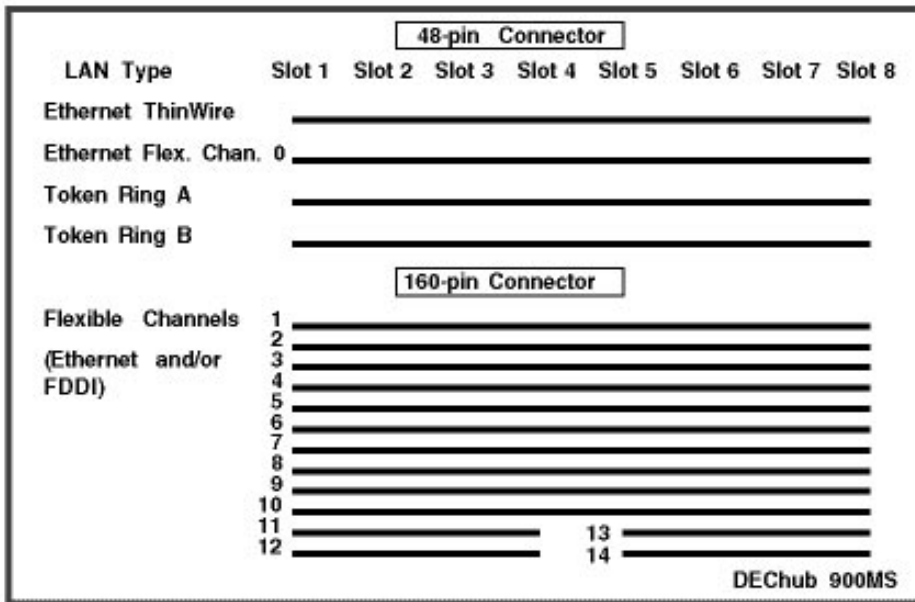
Figure 2-1: DEChub 900MS Backplane Wiring

The hub backplane supports a total of 18 “flex” channels. The 48-pin connector (top connector) supports four LANs—one ThinWire Ethernet, one Ethernet flexible, and two Token Ring. The 160-pin connector (bottom connector) supports 14—10 that span all 8 slots and 4 that span only 4 slots. The LANs on the bottom connector can be configured as Ethernet LANs, FDDI LANs or a mixture of both. LANs are created using the flex channels. In some cases, more than one channel is used to create the LAN. Figure 2-1 illustrates the backplane layout.

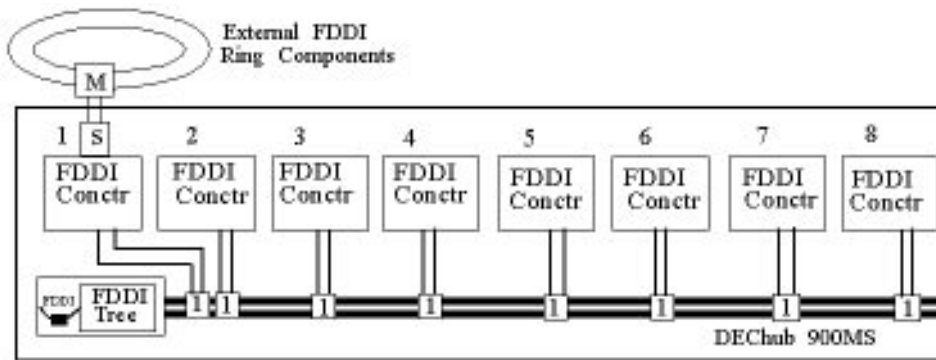
Figure 2-2: FDDI LAN with Modules is a Tree Configuration

In a configuration with a DEChub 900MS fully populated with eight FDDI concentrator modules, all the concentrators are connected in a tree configuration in the hub backplane (See Figure 2-2). The tree root is in slot 1 with its port configured S-Front/M-Back. The other modules have one port configured SM-Back and are connected to the backplane LAN through that port.

Questions	Answers
1. What is the token flow scheme in this configuration?	The token flow is from left to right, however, since slot 1 is the root it comes after slot 8. The token flow on the ring is slot 2>3>4>5>6>7>8>1.
2. How is the tree affected if, for example, the module in slot 4 is removed?	When a module is removed, the adjacent modules are automatically connected to each other. This is true whether FDDI Auto Healing is enabled or disabled or the hub is powered on or off. When the concentrator in slot 4 is removed, the module in slot 3 is connected to the module in slot 5.

Questions	Answers
3. What is the configuration of the tree and the token flow scheme when the module is replaced in slot 4 and reconnected to the FDDI LAN?	If FDDI Auto Healing is enabled when the module is replaced and reconnected to the LAN, the original token flow is restored. If FDDI Auto Healing is not enabled, the module is not reconnected to the LAN when it is replaced.
