PrintServer 20 and turbo PrintServer 20 Service Guide

Order Number EK-TPS20-SG-001

Digital Equipment Corporation Maynard, Massachusetts

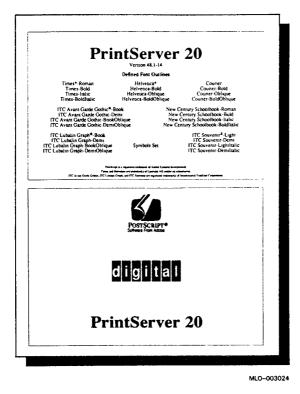
Figure 2-1: Start-Up Page

If configured to do so, the host sends the start-up page to the printer (Figure 2-1). The system manager can disable printing the start-up page from the Remote Server Management menu, which is explained in the *PrintServer Supporting Host for VMS Management/User's Guide* or the *PrintServer Supporting Host for ULTRIX Management/User's Guide*.

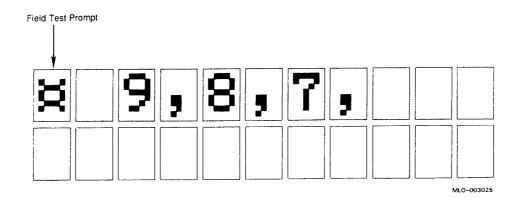
Figure 4-1: Field Test Prompt

To invoke the Field Test Mode, press the Pause key while the self-test is running and after the numbers 9, 8, appear on the panel. You cannot invoke the Field Test Mode after the self-test numbers count down past zero. The appearance of the field test prompt, Figure 4-1, tells you that the Field Test Mode is invoked. Once the Field Test Mode is invoked, you must wait for the self-test to end before you can enter commands.

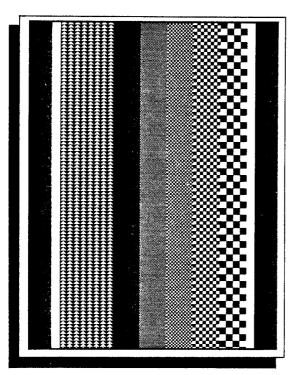
Figure 4-3: Controller Board Test Pattern

Figure 4–3 shows the controller board test pattern, which resides on the controller board ROM memory.

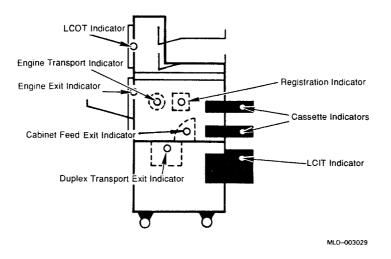
Figure 7–1: Paper and Jam Path Indicators

The operator panel indicators do not directly correspond to a paper path sensor. The sensors dynamically track and detect the paper traveling through the printer. The sensors also detect stalled paper if the sheet is directly underneath the sensor. Figure 7-1 shows the location and gives a name to each indicator. Figure 7-2 shows the location and names each paper path sensor.

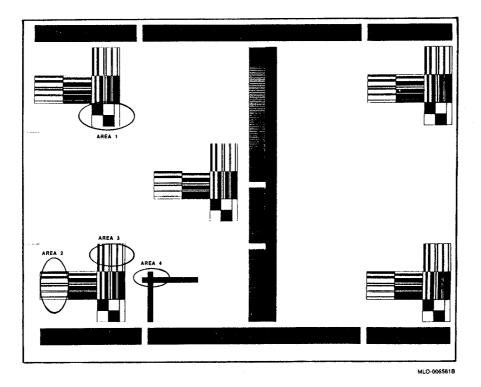
Figure 8-14: Pattern B

b. For the turbo PrintServer 20, print the 0103 test page and the controller board test pattern B. Press keys 3 and 6 in Field Test Mode to generate test pattern B. (See Figure 8-14.)

Figure 8-14 Any unprinted area

Examine the continuity of the line in Figure 8-14 for further clues.

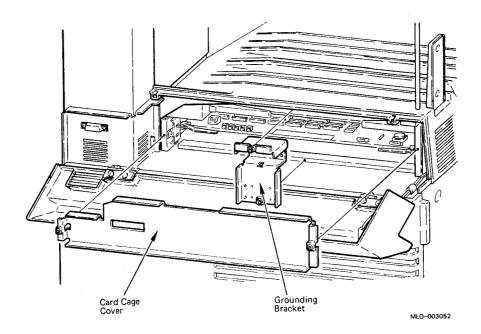
Figure 9–1: Removing the Card Cage Cover and Grounding Bracket

- 1. Open the operator panel cover.
- 2. Remove the card cage cover by loosening its two screws.
- 3. Remove the grounding bracket by loosening its two screws.

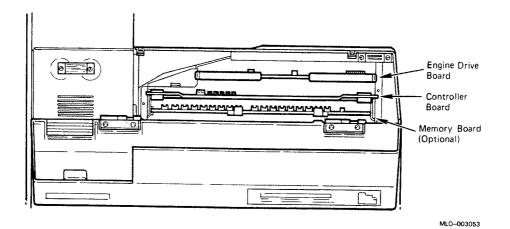
Figure 9–2: Removing Circuit Boards

4. Remove the circuit board by pulling open the release handles on each side of the board.

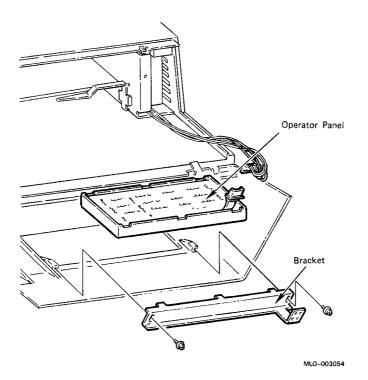
Figure 9-3: Removing the Operator Panel

- 1. Open the operator panel cover.
- 2. Disconnect the operator panel cable.
- 3. Remove the bracket by removing its two screws.
- 4. Lift out the operator panel.

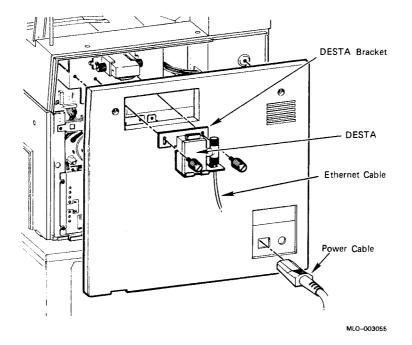
Figure 9-4: Removing the Rear Cover

- 1. Disconnect the power cable.
- 2. Disconnect the Ethernet cable.
- 3. Remove the DESTA (if present).
- 4. Remove the DESTA bracket.
- 5. Remove the rear cover by loosening its two screws.

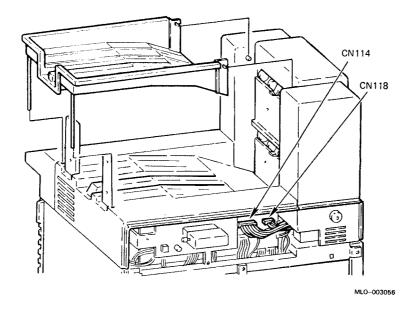
Figure 9-5: Disconnecting the LCOT Cables

- 1. Remove the top output paper tray.
- 2. Remove the rear cover (Section 9.3).
- 3. Disconnect the two LCOT cables from the mother board (CN114 and CN118).

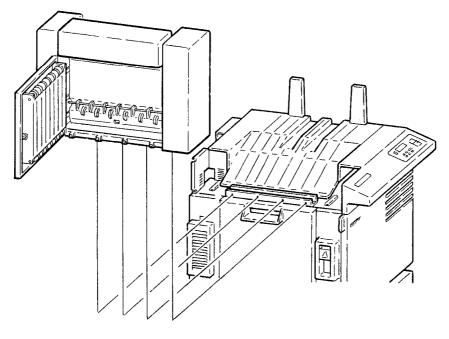
Figure 9-6: Removing the LCOT

- 4. Open the LCOT side door and loosen the four screws.
- 5. Remove the LCOT by sliding it out the side of the printer.

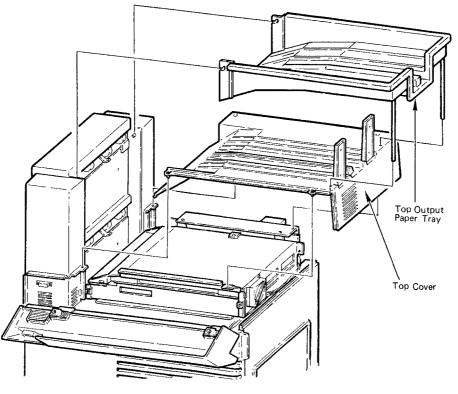
Figure 9–7: Removing the Top Cover

- 1. Remove the paper cassettes.
- 2. Remove the rear cover (Section 9.3).
- 3. Remove the top output paper tray.
- 4. Open the operator panel cover.
- 5. Remove the top cover by loosening its four screws.

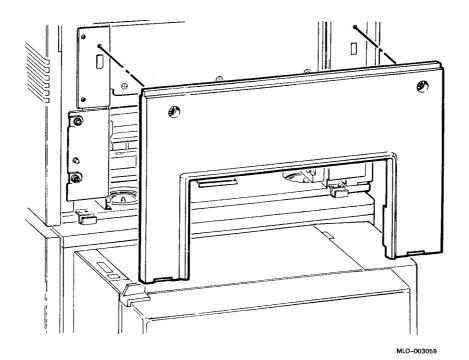
Figure 9-8: Removing the Right Side Cover

6. Remove the right side cover by loosening its two screws.

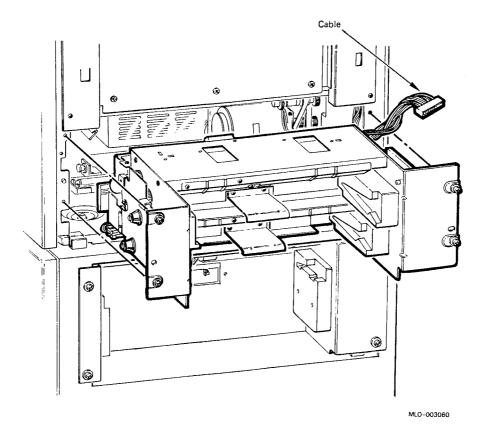
Figure 9-9: Removing the Cassette Paper Feed Unit

- 7. Loosen the four paper feed unit screws.
- 8. Pull the paper feed unit out a few inches and disconnect the top cable from the feed unit circuit board.
- 9. Remove the feed unit by pulling it out of the printer.

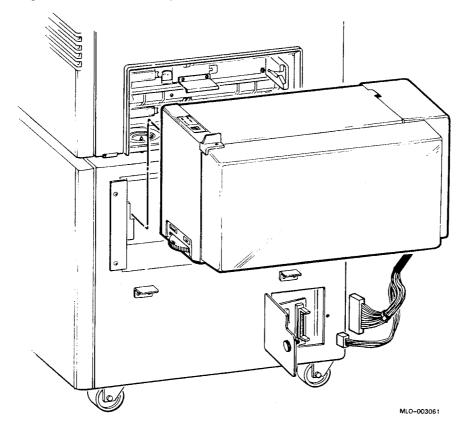
Figure 9-10: Removing the LCIT

- 1. Remove the top and bottom paper cassettes.
- 2. Open the small cable door on the cabinet below the LCIT and disconnect the large and small cables.
- 3. Lift the LCIT up slightly and slide it out from the printer.

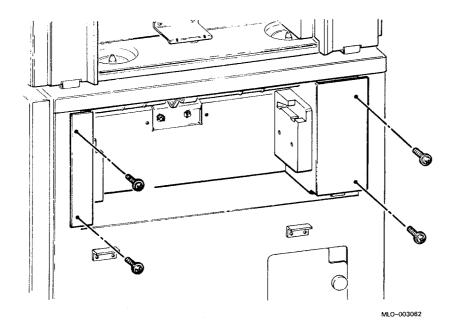
Figure 9-11: Removing the LCIT Feed Unit Screws (Side of Cabinet)

- 1. Remove the LCIT (Section 9.6).
- 2. Remove the four feed unit screws.

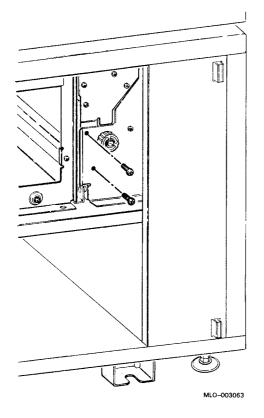
Figure 9-12: Removing the LCIT Feed Unit Screws (Front of Cabinet)

3. Open the cabinet door and remove the two feed unit screws.

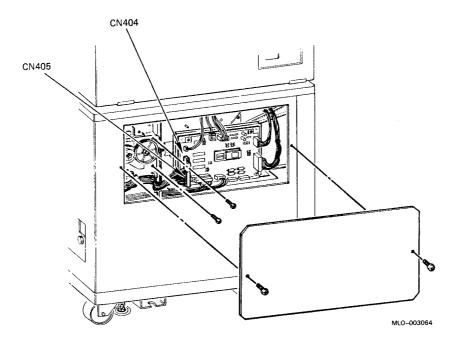
- 4. Remove the rear cabinet cover by removing its two screws.
- 5. Remove the two feed unit screws.
- 6. Disconnect the feed unit cables (CN404 and CN405) from the duplexer/LCIT drive board and remove the cables from the wiring harness retainer.

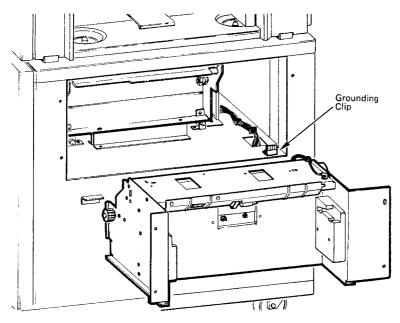
Figure 9–14: Removing the LCIT Feed Unit

7. Slide the feed unit out of the printer.

CAUTION: Be sure not to bend the grounding clip on the right side of the cabinet opening when removing or installing the feed unit.

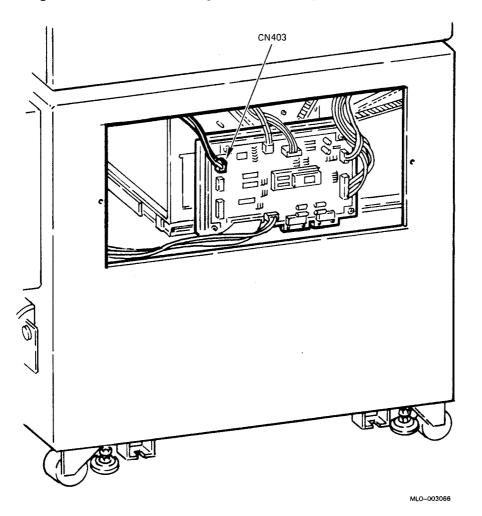
Figure 9–15: Disconnecting the Cabinet Paper Feed Unit Cable

- 1. Remove the LCIT (Section 9.6).
- 2. Remove the LCIT feed unit (Section 9.7).
- 3. Disconnect the feed unit cable from the duplexer/LCIT drive board (CN403).

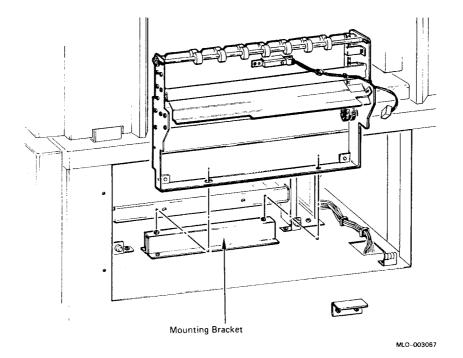
4. Lift the feed unit up from the bottom just enough to clear the alignment pins on the mounting bracket and then pull the unit out.

NOTE: The feed unit requires an exact position in the cabinet to feed paper properly. Because of this close tolerance, the feed unit may fit tightly in the cabinet. When installing the feed unit, insert it so that the top is in position first and then slide the bottom over the alignment pins on the mounting bracket.

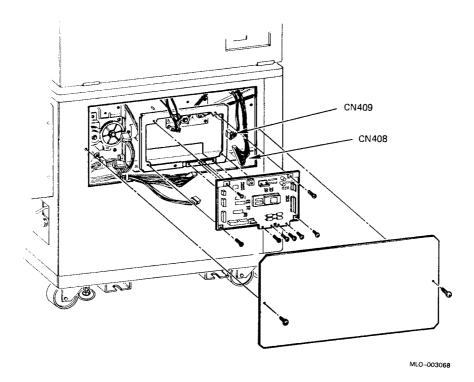
Figure 9–17: Disconnecting the Duplexer Cables

- 1. Remove the rear cover of the cabinet by loosening its two screws.
- 2. Disconnect the duplexer unit cables (CN408 and CN409) from the duplexer/LCIT drive board.

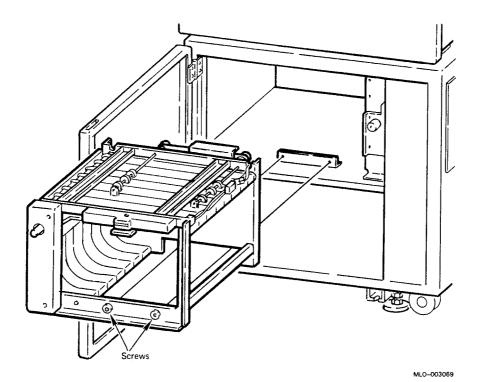
Figure 9–18: Removing the Duplexer Unit

- 3. Open the cabinet door.
- 4. Remove the duplexer unit by loosening its two screws.

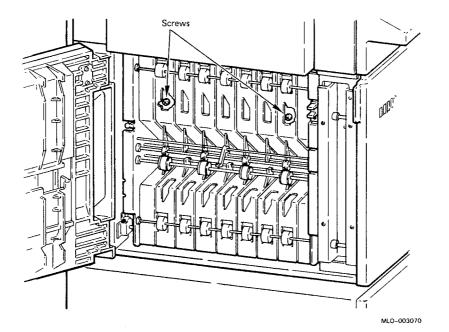
Figure 9–19: Loosening the Fork Gate Unit Screws

1. Open the left side door and loosen the two exit transport screws.

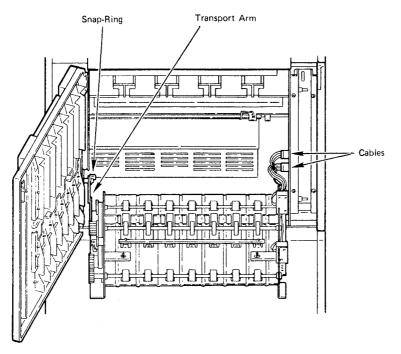
Figure 9-20: Disconnecting the Cables and Snap-Ring

- 2. Lower the fork gate unit and disconnect its two cables (one 6-pin and one 7-pin) from the print engine.
- 3. Remove the snap-ring from the stand-off on the left side of the print engine.
- 4. Slide the transport arm off the stand-off to remove the transport unit.

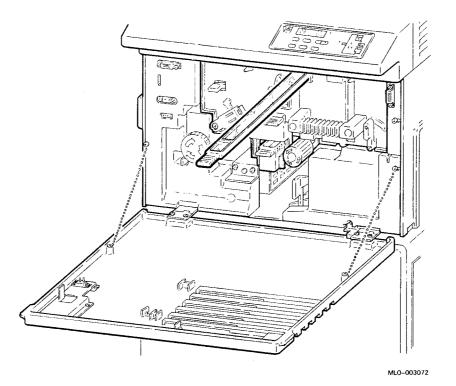
Figure 9-21: Removing the Shield Glass

1. Open the front cover and remove the shield glass.

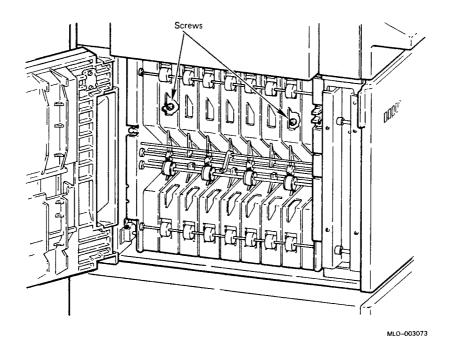
Figure 9–22: Loosening the Fork Gate Unit Screws

2. Open the lower left side door and loosen the two fork gate unit screws.

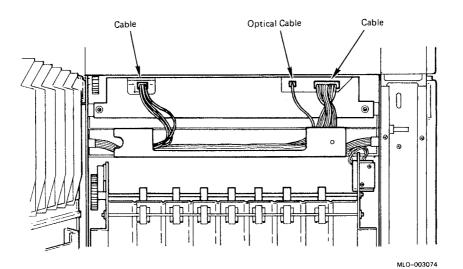
Figure 9-23: Disconnecting the Cables from the Optical Unit

3. Lower the fork gate unit and disconnect the three cables from the optical unit.

CAUTION: Be sure to carefully disconnect the optical cable by its plug and not by its cable. Disconnecting it by pulling on the cable can result in damage to the optic wire.

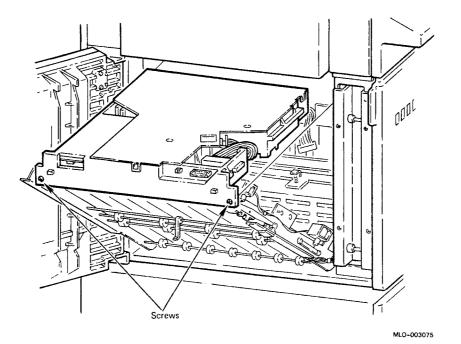
Figure 9-24: Removing the Optical Unit

4. Remove the optical unit from the printer by loosening its two screws and sliding the unit out.

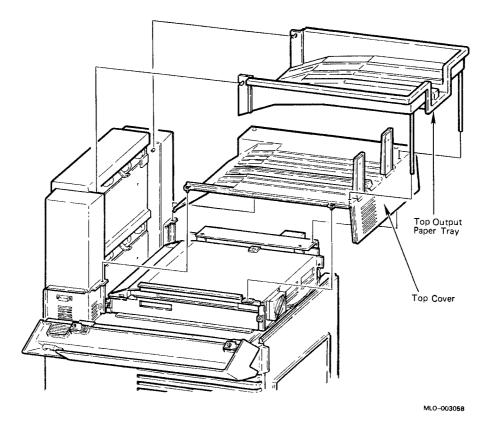
Figure 9-25: Removing the Top Cover

- 1. Remove the top output paper tray.
- 2. Remove the rear cover (Section 9.3).
- 3. Open the operator panel cover.
- 4. Remove the top cover by loosening its four screws.

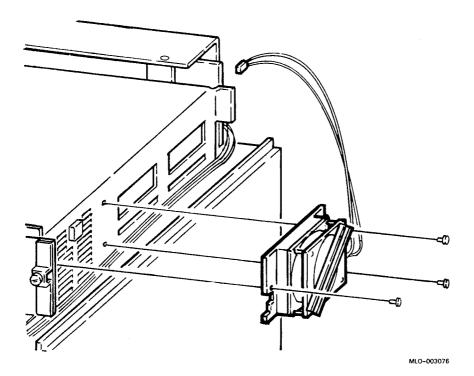
Figure 9-26: Removing the Card Cage Fan

- 5. Disconnect the fan cable (CN123) from the mother board and remove it from the wiring harness retainers.
- 6. Remove the fan (with bracket) by removing the three bracket screws.

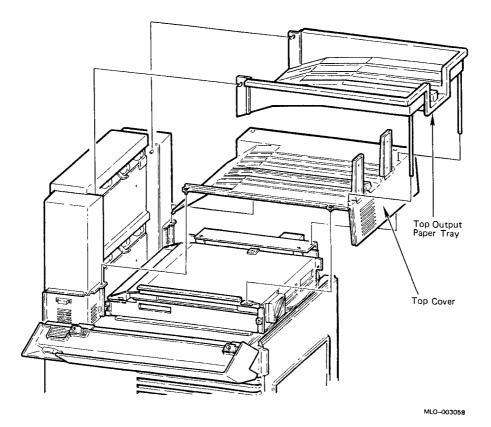
Figure 9-27: Removing the Top Cover

- 1. Remove all the circuit boards from the card cage (Section 9.1).
- 2. Remove the rear cover (Section 9.3).
- 3. Remove the top output paper tray.
- 4. Remove the top cover by loosening its four screws.

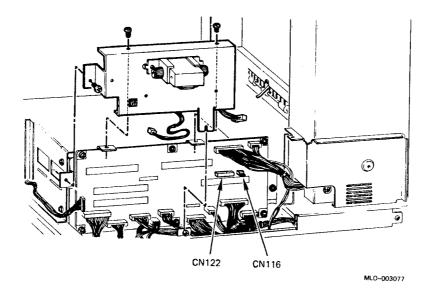
Figure 9-28: Removing the Interface Bracket

- 5. Disconnect the two interface bracket cables (CN116 and CN122) from the mother board.
- 6. Loosen the bottom bracket screw.
- 7. Remove the interface bracket by removing its three screws.

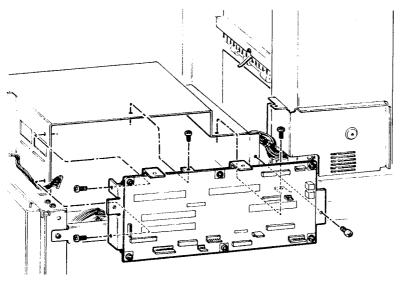
Figure 9-29: Removing the Mother Board

8. Disconnect the remaining cables from the mother board.

CAUTION: Be sure to carefully disconnect the two optical cables by their plugs and not by their cables. Disconnecting them by pulling on their cables can result in damage to the optic wire.

9. Remove the mother board (with its bracket) by removing its five screws.

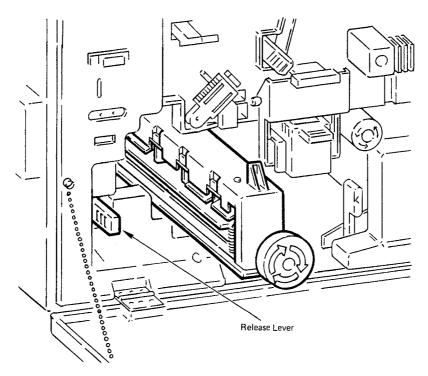
WARNING: The fusing unit may be hot. Be sure printer has been turned off and has had sufficient time to cool down before handling the fusing unit.

- 1. Open the front cover.
- 2. Push the fusing unit release lever to the left and pull the fusing unit out until it stops.

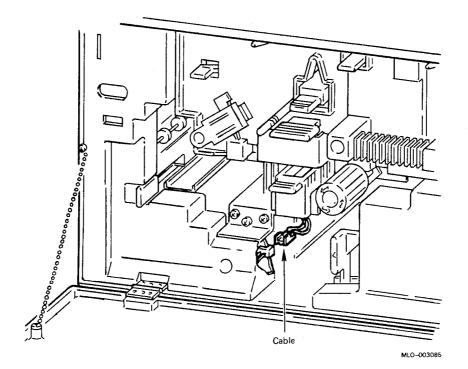
Figure 9-32: Disconnecting the Transport Unit Cable

- 1. Remove the fusing unit (Section 9.14).
- 2. Disconnect the transport unit cable from the print engine.

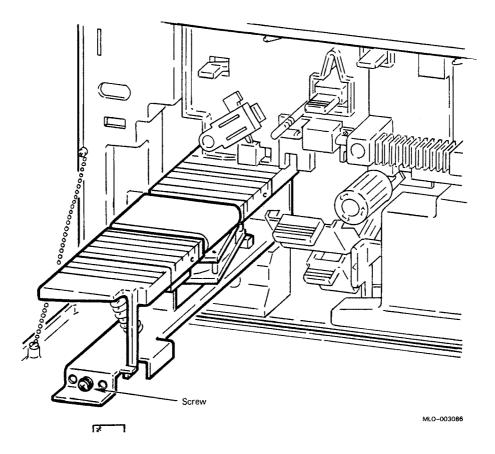
Figure 9-33: Removing the Transport Unit

- 3. Lower the transfer/separation charger guide.
- 4. Slide the transport unit out from the printer by loosening its screw.

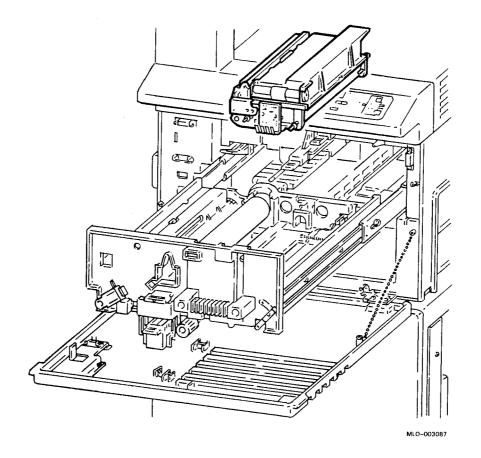
Figure 9–34: Removing the Development Unit

CAUTION: Be careful not to damage the OPC drum when removing or replacing the development unit.

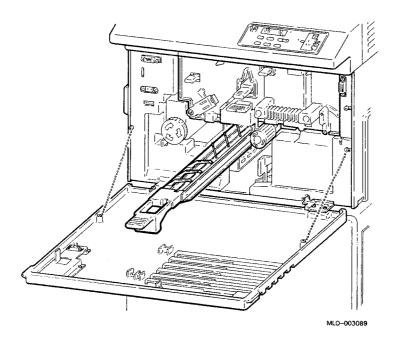
Figure 9-36: Removing the Transfer/Separation Charger

Carefully remove and replace the transfer/separation charger, making sure the charger slides along the guides.

- 1. Open the front cover.
- 2. Remove the transfer/separation charger.

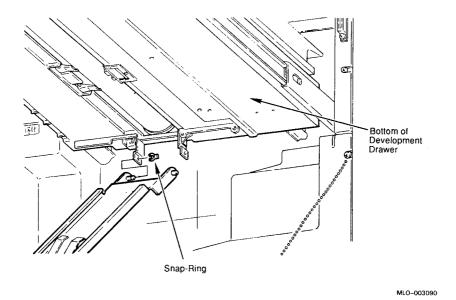
Figure 9–37: Removing the Transfer/Separation Charger Guide

- 3. Remove the registration roller unit (Section 9.17).
- 4. Remove the plastic snap-ring at the rear (left side) of the charger guide.
- 5. Move the charger guide to the left to remove it from the rear bracket.

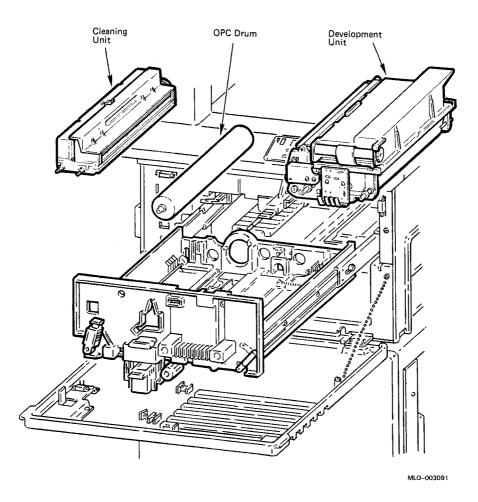
Figure 9–38: Removing the Drawer Components

- 6. Turn the development unit release lever clockwise to disengage the development unit from its operating position.
- 7. Remove the development unit (with the toner cartridge) by lifting it up and out of the drawer.

- 8. Press the top of the cleaning unit release lever to disengage the cleaning unit from its operating position.
- 9. Remove the cleaning unit from the drawer.
- 10. Remove the OPC drum from the drawer.

CAUTION: Place the drum on a clean cloth or paper and cover it to protect the drum surface from exposure to light. When handling the drum, do not get fingerprints on the drum surface. Fingerprints damage the surface of the drum and produce print quality problems.

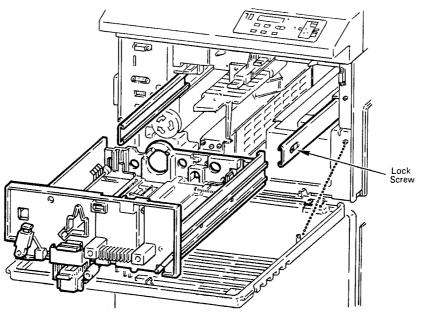
Figure 9–39: Removing the Development Drawer

11. Loosen the drawer lock screws (left and right sides) and slide them forward.

12. Remove the drawer by sliding it straight out.

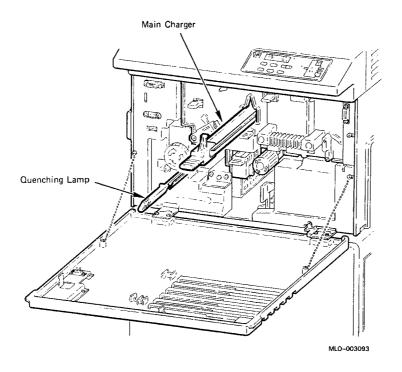
Figure 9-40: Removing the Main Charger and Quenching Lamp

- 1. Remove the main charger.
- 2. Remove the quenching lamp.

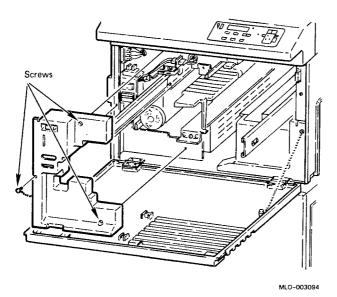
Figure 9-41: Removing the Left Inside Cover

- 3. Remove the development drawer (Section 9.18).
- 4. Remove the front cover chain screw (left side).
- 5. Remove the left inside cover by loosening its two screws.

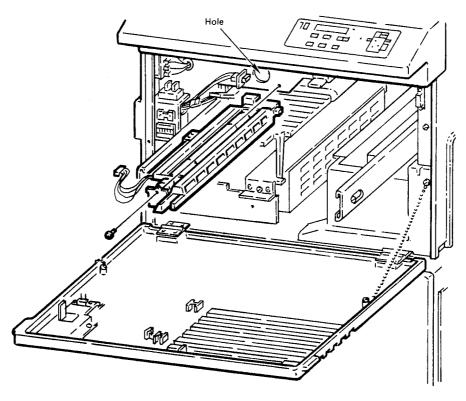
Figure 9-42: Removing the Main Fan

- 6. Disconnect the main fan cable and pass it through the hole in the frame.
- 7. Remove the fan by removing its screw.

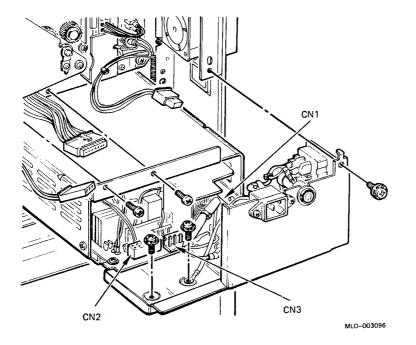
Figure 9-43: Removing the Low-Voltage Power Supply

- 3. Disconnect the 16-pin cable and the 3-pin cable (CN2 and CN3) from the power supply.
- 4. Pull the power supply out a few inches and disconnect the 2-pin cable (CN1) from the power supply.
- 5. Remove the power supply by pulling it straight out of the printer.

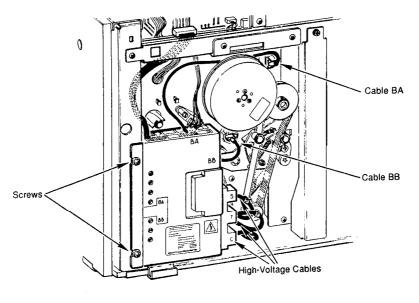
- 1. Remove the rear cover (Section 9.3).
- 2. Disconnect the three high-voltage cables (S, T, and C) from the power supply.
- 3. Disconnect the power supply cable (CN106) from the mother board and remove the cable from the wiring harness retainer.
- 4. Disconnect cable BA from the printer and remove the cable from its wiring harness retainers.
- 5. Disconnect cable BB from the printer.
- 6. Remove the power supply by loosening its two screws.

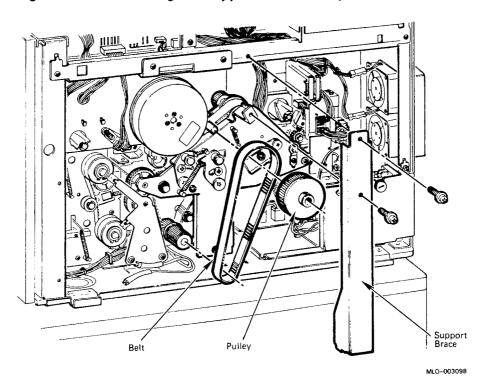
Figure 9-45: Removing the Support Brace, Pulley, and Belt

- 1. Remove the cassette paper feed unit (Section 9.5).
- 2. Remove the high-voltage power supply (Section 9.21).
- 3. Remove the vertical support brace by removing its two screws.
- 4. Loosen the allen screw on the pulley.
- 5. Remove the pulley, timing belt, and bearing from the engine by sliding them off their shafts.

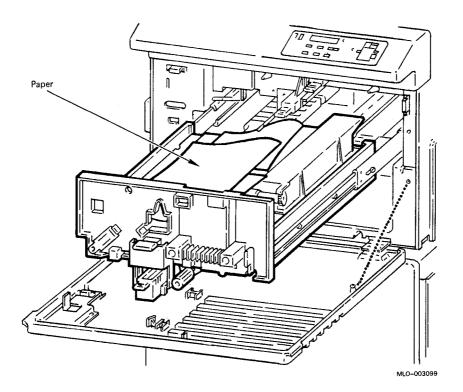
Figure 9–46: Covering the OPC Drum

- 6. Open the front cover and pull out the development drawer.
 - \rightarrow Cover the OPC drum with several sheets of paper, so it will not be exposed to the light.

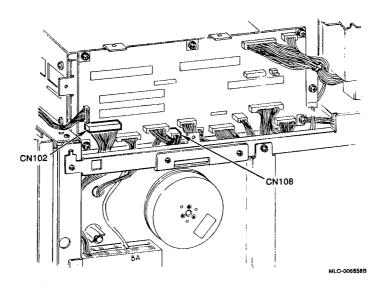
Figure 9-47: Connector Locations

- 7. Disconnect the development motor cable (CN108) from the mother board.
- 8. Disconnect the paper feed cable (CN102) from the mother board.

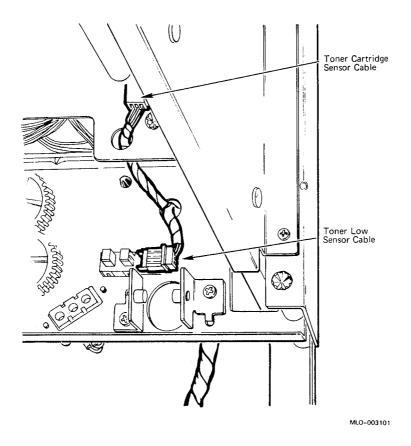
Figure 9-48: Cable and Sensor Locations

9. Disconnect the following two sensor cables from their sensors.

- a. Disconnect the toner cartridge sensor cable from its sensor and run it through the hole in the chassis.
- b. Disconnect the toner low sensor cable from its sensor and run both sensor cables through the hole in the development motor unit.

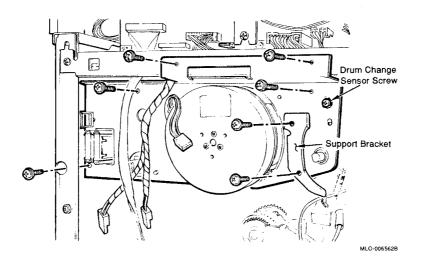
Figure 9–49: Removing the Development Motor Unit

- 10. Remove the OPC drum change sensor screw.
- 11. Remove the support bracket and development motor unit.

NOTE: Use the hole in the frame to access the lower left screw.

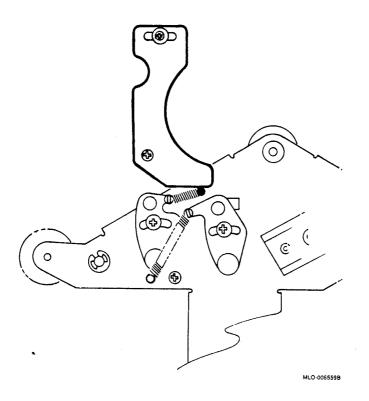
Figure 9-50: Replacing the Support Bracket

NOTE: To attach the support bracket, slide the bracket downward until it contacts the pin on the side plate of the main drive unit. Then tighten the screws to secure the bracket.

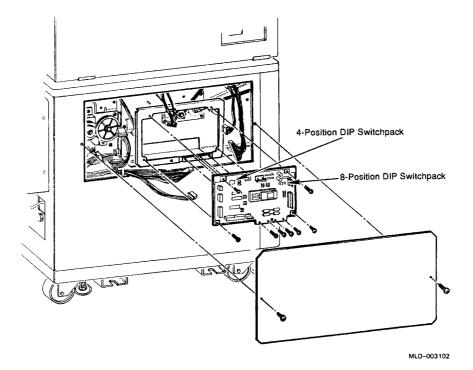
Figure 9-51: Removing the Duplexer/LCIT Drive Board

NOTE: When installing a new duplexer/LCIT drive board:

- Set the dip-switches on the two switchpacks to match the settings on the old board. (See Chapter 3.)
- Place the plastic insulators between the mounting bracket and the two heat sinks on the bottom transistors.
- Plug the fiber optics cable correctly into the connector. The connector is keyed and the plug should fit snugly. If the cable is plugged in the wrong direction, jobs will not print.

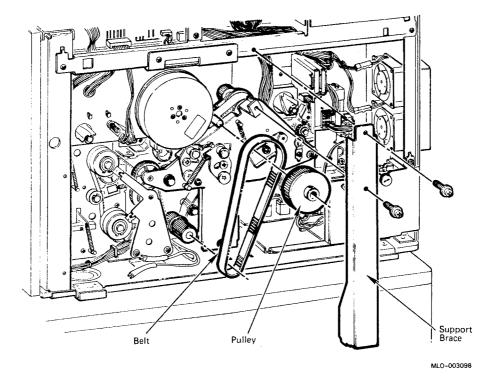
- 1. Remove the rear cover (Section 9.3).
- 2. Remove the vertical support brace by removing its two screws.
- 3. Loosen the allen screw on the pulley.
- 4. Remove the pulley, timing belt, and bearing from the engine by sliding them off their shafts.

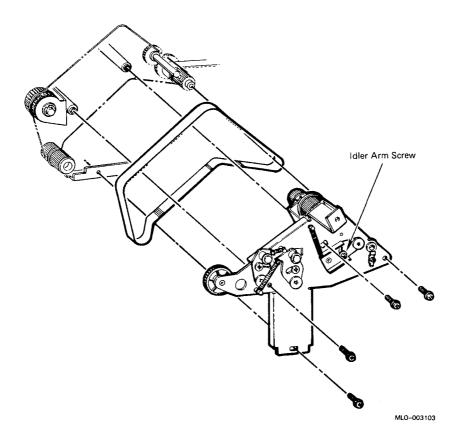
Figure 9-53: Removing the Main Drive Unit and Belt

5. Loosen the idler arm screw.

- a. Turn on the printer power and loosen the idler arm screw.
- b. After warm-up, when the main motor runs, you will see the main timing belt tighten up.
- c. Tighten the idler arm screw.
- 6. Remove the four screws from the main drive unit.
- 7. Remove the main drive unit by pulling it out while pushing down on the idler arm to relieve tension on the drive belt.

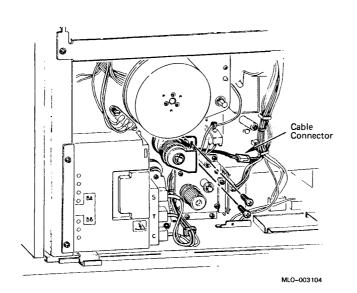
Figure 9-54: Removing the Registration Clutch

- 1. Remove the main drive unit (Section 9.24).
- 2. Disconnect the registration clutch cable from its wiring connector.
- 3. Remove the registration clutch by removing its two screws.

CAUTION: Be careful not to damage the high-voltage power supply cables that run through the cable retainer on the registration clutch. These cables should be gently pulled from the retainer when removing the clutch.

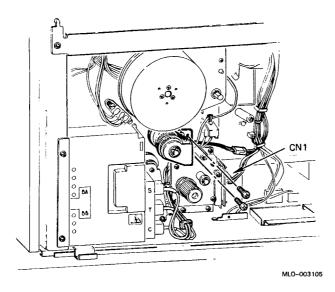
Figure 9-55: Removing the Main Motor

- 1. Remove the main drive unit (Section 9.24).
- 2. Disconnect the cable (CN1) from the main motor circuit board.
- 3. Gently remove the high-voltage power supply cables from their retainers on the motor bracket and the engine chassis.
- 4. Remove the main motor by removing its three screws.

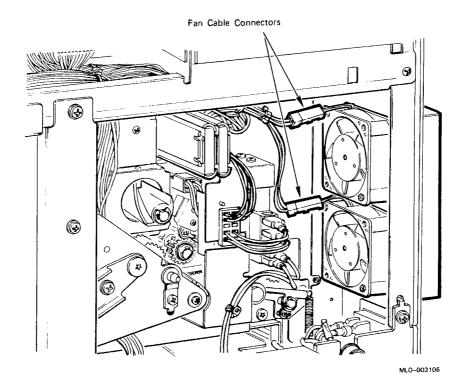
Figure 9-56: Disconnecting the Ozone Fan Cables

- 1. Remove the rear cover (Section 9.3).
- 2. Disconnect the two fan cables.

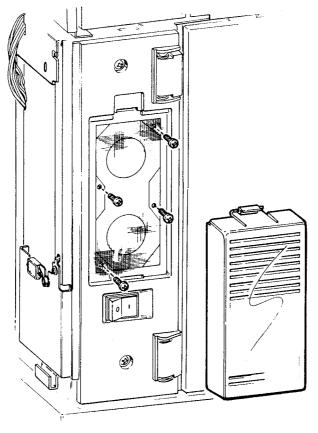
Figure 9-57: Removing the Ozone Fans

- 3. Remove the ozone filter cartridge.
- 4. Remove the fans by removing their four screws and nuts.

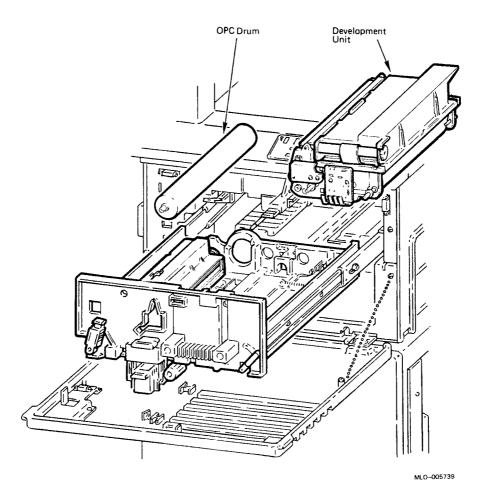
Figure 10–1: Removing the Development Drawer Components

- d. Remove the development unit from the development drawer.
 - \rightarrow Discard the development unit.

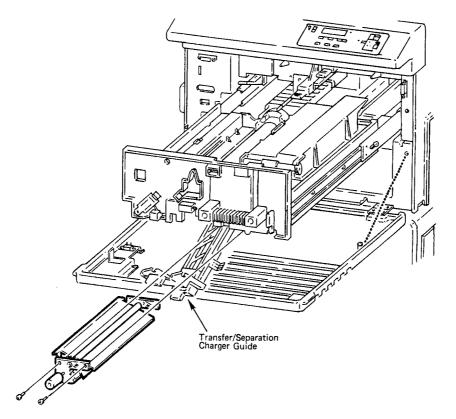
Figure 10-2: Removing the Registration Roller Unit

CAUTION: Take care not to damage or bend the mylar edge of the registration roller unit.

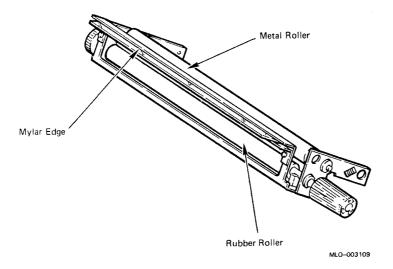
- c. Vacuum the rubber and metal rollers on the registration roller unit while turning the roller knob.
- d. Clean both rollers and the mylar edge with a clean damp cloth until no toner remains.

CAUTION: Take care not to damage or bend the mylar edge of the registration roller unit.

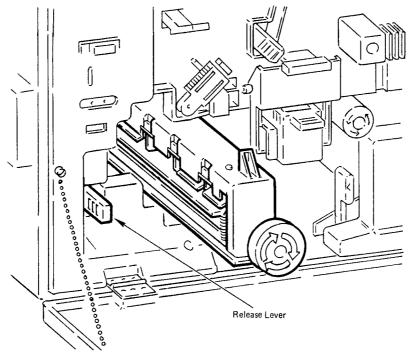
Figure 10-5: Releasing the Fusing Unit

1. Push the fusing unit release lever to the left and pull the fusing unit out until it stops.

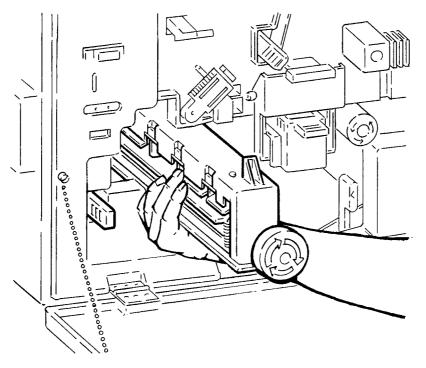
- 2. While supporting the fusing unit with your hand, push the release lever to the left once again and pull the fusing unit out of the printer.
 - \rightarrow Discard the fusing unit.

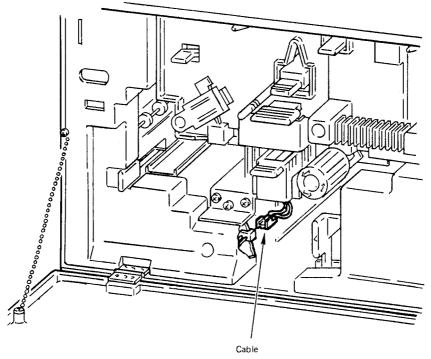
Figure 10-7: Disconnecting the Transport Unit Cable

3. Disconnect the transport unit cable of the print engine.

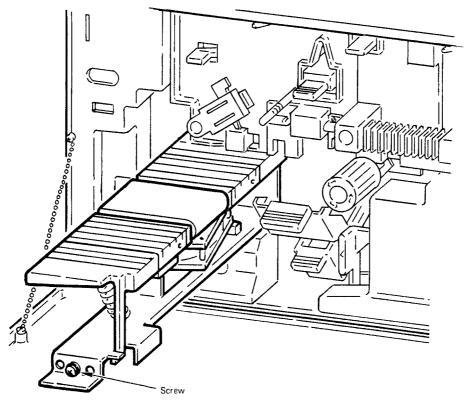
Figure 10-8: Removing the Transport Unit

- 4. Lower the transfer/separation charger guide.
- 5. Slide the transport unit out of the printer by loosening its screw.

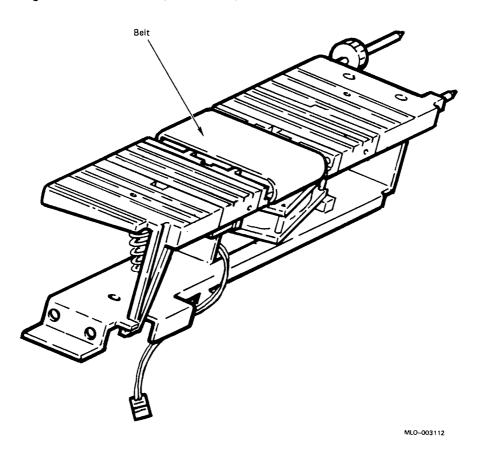
Figure 10-9: Cleaning the Transport Unit

- 6. Vacuum the transport unit thoroughly while rotating the transport unit belt.
- 7. Clean all surfaces of the transport unit with a clean damp cloth.

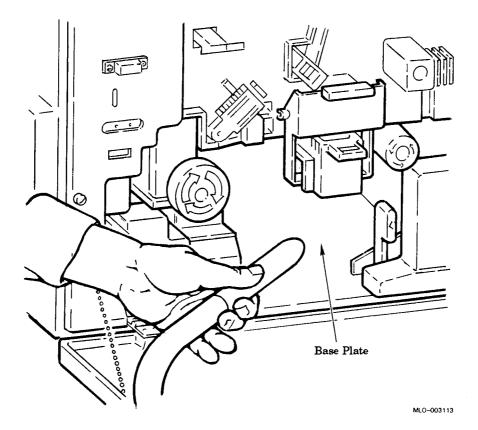
Figure 10-10: Vacuuming the Print Engine Area

- 8. Reinstall the transport unit.
- 9. Install a new fusing unit.
- 10. Vacuum any toner remaining on the engine base plate.
- 11. Close the front cover.

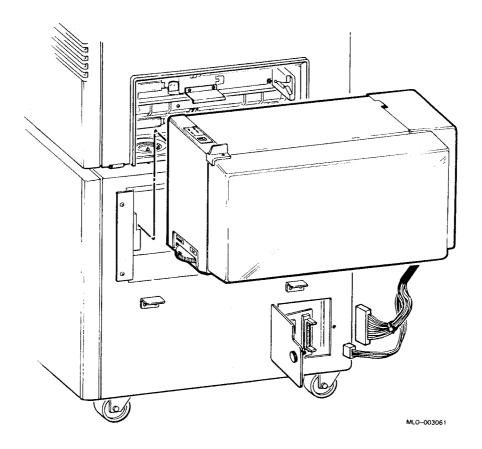
Figure 10-12: Removing the LCIT

- 1. Open the small cable door on the cabinet below the LCIT and disconnect the large and small cables.
- 2. Lift the LCIT up slightly and slide it out of the printer.

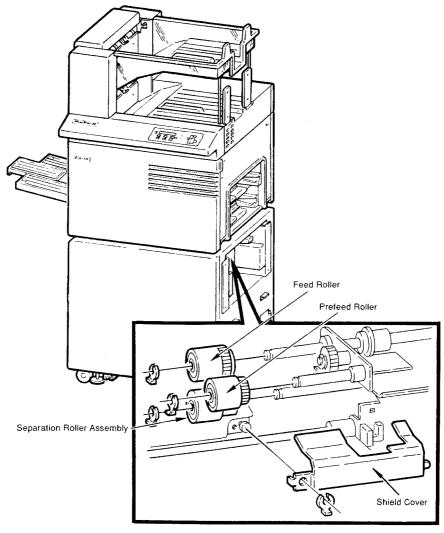
Figure 10-13: Replacing the LCIT Feed, Prefeed, and Separation Rollers

- 3. Remove the two snap-rings from the LCIT feed unit shield cover and remove the cover.
- 4. Remove the snap-ring from the prefeed roller and slide the roller off its shaft.
- 5. Remove the snap-ring from the feed roller and slide the roller off its shaft.

6. Remove the snap-ring from the separation roller assembly and slide the assembly off its shaft.
