# DIGITAL StorageWorks HSZ50 Array Controller

## HSOF Version 5.1 Service Manual

Part Number: EK-HSZ50-SV.C01

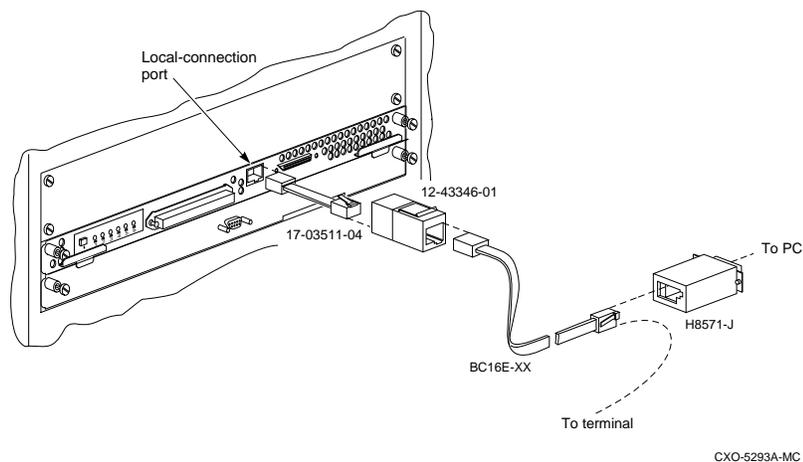
1. Connect a maintenance terminal to the controller that does NOT require service, as shown in Figure 2-1.

**Figure 2-1 Connecting a maintenance terminal**

1. If the controller is fully or partially functioning, connect a maintenance terminal to the controller. See Figure 2-1. If the controller is not functioning, try to restart the controller.

```
HSZ50>RESTART_OTHER
```
6. Attach a maintenance terminal to the new controller. See Figure 2-1.
7. Press and hold the controller's green reset (//) button, while inserting the program card. The program card eject button will extend when the card is fully inserted.
8. Release the reset button to initialize the controller.
9. Enter the following command at the CLI:

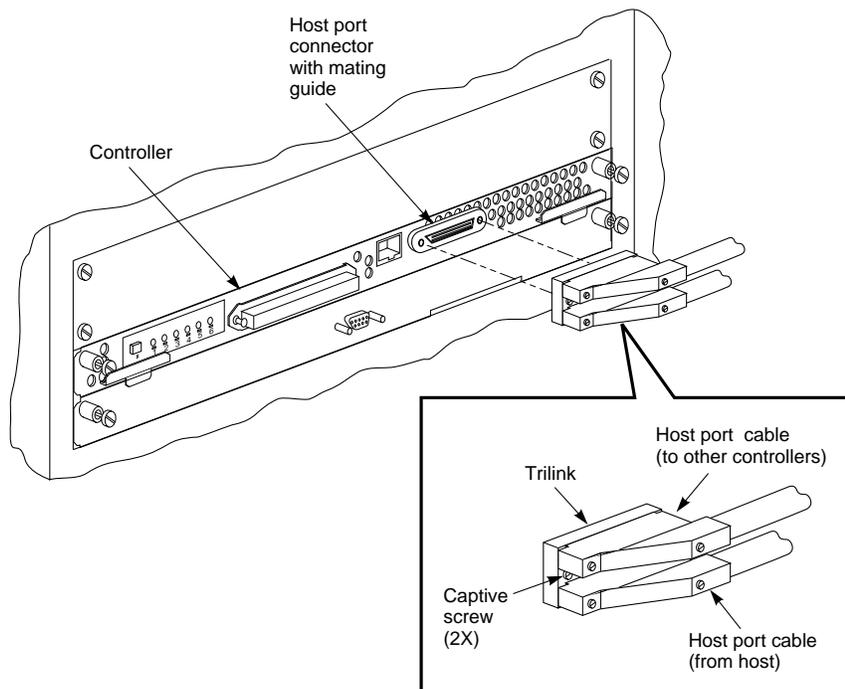
CXO-5298A-MC

11. Loosen the captive screws that secure the trilink connector to the controller requiring service. Do not remove the connector. See Figure 2-2.

**Figure 2-2 Disconnecting the trilink connector**

9. Unsnap and remove the program card ESD shield. See Figure 2-3.
10. Eject the program card by pressing and holding the Reset button (//), then pressing the eject button next to the program card. Remove the program card and save it for the replacement controller. See Figure 2-3.
11. Loosen the captive screws on the trilink connector and remove the trilink. See Figure 2-2.
12. Loosen the captive retaining screws on the controller's front bezel.

where *n,n,n,n* are equal to all host port SCSI target IDs noted in Step 3.
5. Loosen the captive screws on the trilink connector and remove the trilink. See Figure 2-2.

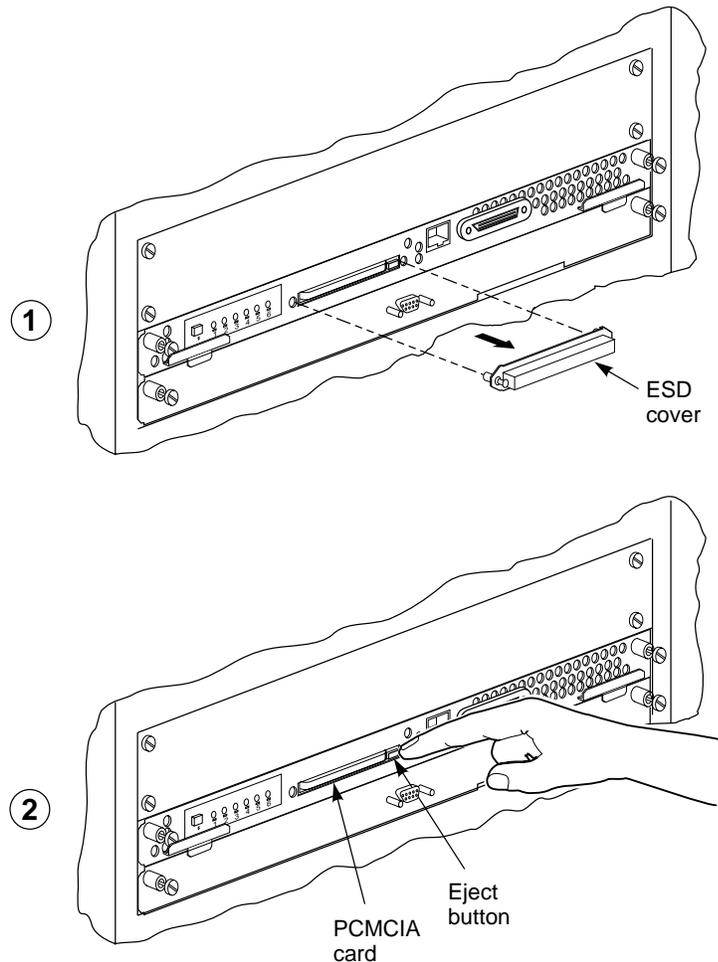
CXO-5302A-MC

5. Eject the program card by pressing and holding the Reset button (//), then pressing the eject button next to the program card. See Figure 2-3.
  - If you are not replacing the controller module, leave the program card in the ejected position.
  - If you are replacing the controller, remove the program card and save it for use in the replacement controller.

**Figure 2-3 Removing the program card**

8. Unsnap and remove the program card ESD shield. See Figure 2-3.
9. Eject the program card by pressing and holding the Reset button (//), then pressing the eject button next to the program card. Remove the program card. Save it for the replacement controller. See Figure 2-3.

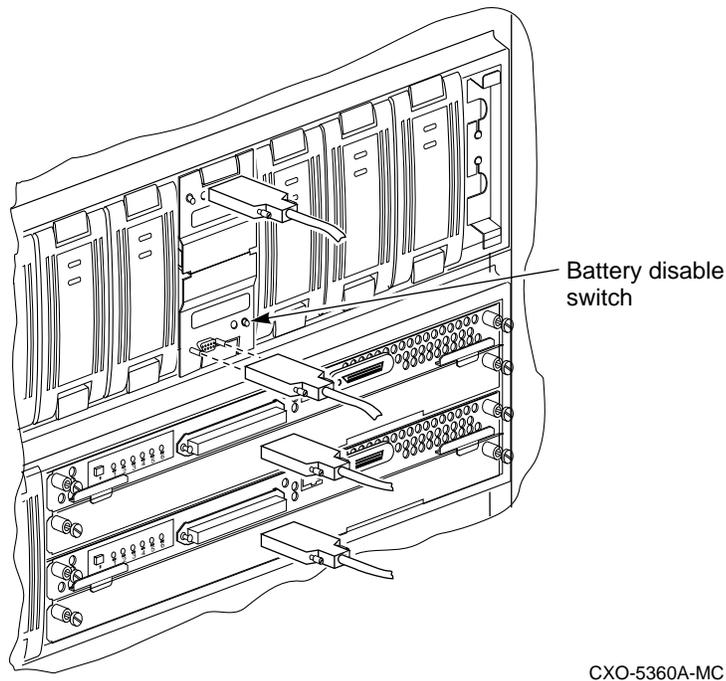
CXO-5360A-MC

If you are removing the cache module, disconnect the battery from the cache side only.
8. Disable the ECB by pressing the battery disable switch. See Figure 2-4.

**Figure 2-4** Disconnecting the battery cable and disabling the ECB

7. If you are replacing the cache module, loosen the screws on the ECB cable and disconnect the cable from the cache module. See Figure 2-4.
8. Disable the ECB by pressing the battery disable switch on the battery module front panel. See Figure 2-7.

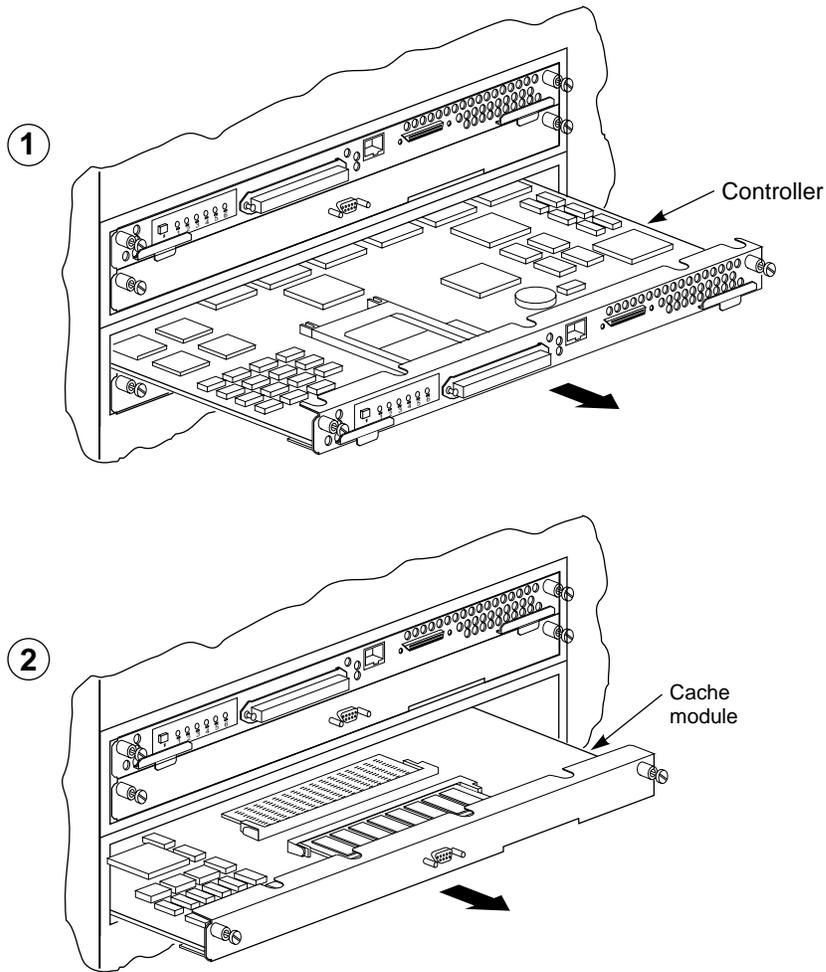
CXO-5284A-MC

9. Slide the defective controller out of the shelf and note its location. See Figure 2-5.

Figure 2-5 Removing controllers and cache modules

```
Port 1 restarted.  
Port 2 restarted.  
Port 3 restarted.  
Port 4 restarted.  
Port 5 restarted.  
Port 6 restarted.
```
11. If you are replacing the cache module, remove it now. See Figure 2-5.

13. Loosen the controller from the shelf backplane with a gently rocking motion. Slide the controller module out of the shelf, noting in which rails it was seated. See Figure 2-5.
14. If you are replacing the cache module, loosen the screws on the cache module's front bezel.
15. Loosen the cache module from the shelf backplane with a gentle rocking motion and slide the module out of the shelf. See Figure 2-5.

10. Loosen the controller from the shelf backplane with a rocking motion. Slide the controller module out of the shelf, noting in which rails it was seated. See Figure 2-5.

11. If you are replacing the cache module, loosen the screws on the cache module's front bezel.
12. Loosen the cache module from the shelf backplane with a rocking motion and slide the module out of the shelf. See Figure 2-5.

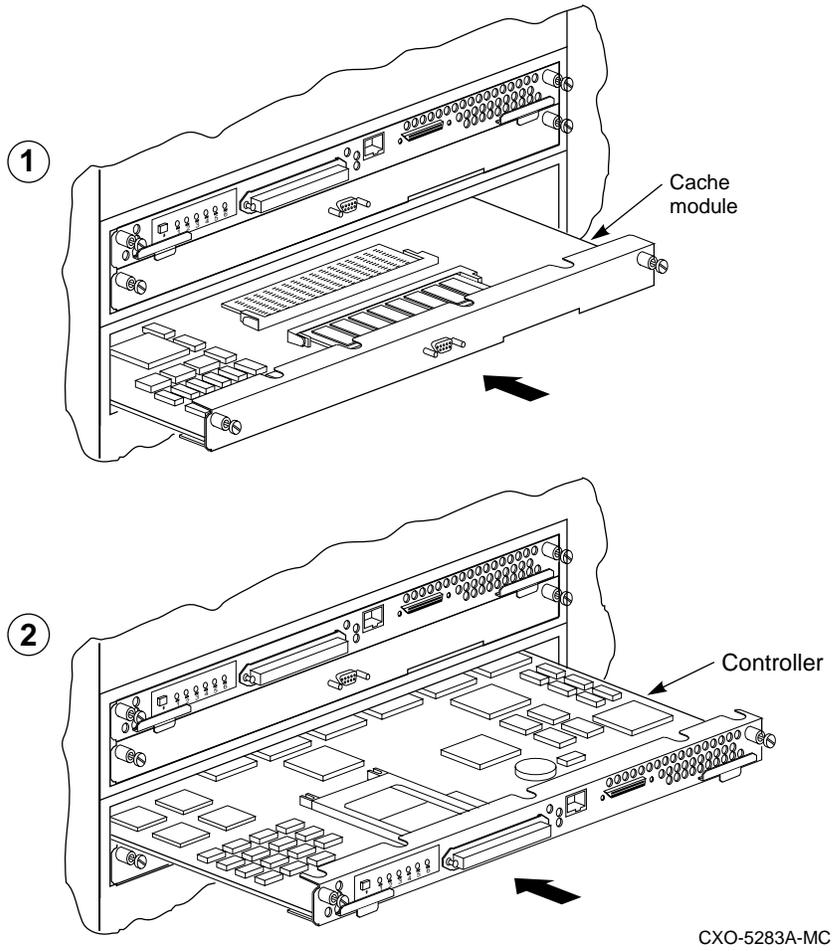
5. Insert the cache module by sliding it straight in along the rails and then push firmly to seat it in the backplane. See Figure 2-6.
6. Insert the controller module by sliding it straight in along the rails and then push firmly to seat it in the backplane. See Figure 2-6.

Figure 2-6 Installing controllers and cache modules

1. If you removed the cache module in the previous procedure, slide the new cache module into the shelf making sure you are using the correct slot.
2. Slide the new controller module into the shelf using the same rails from which you removed the module. See Figure 2-6.

1. If you removed the cache module in the previous procedure, slide the new cache module into the shelf. Make sure you use the correct slot.
2. Slide the new controller module into the shelf using the same rails from which you removed the module. See Figure 2-6.

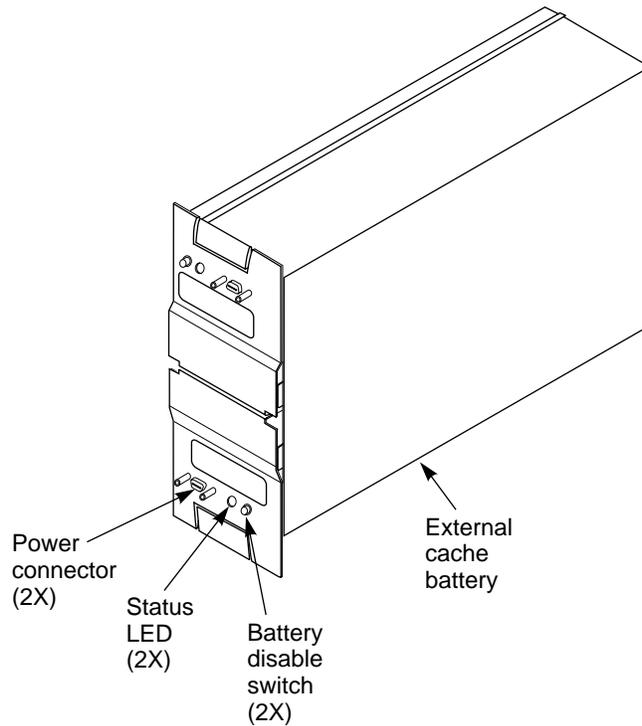
CXO-5267A-MC

**Figure 2-7 Disabling the ECB**

6. If you are replacing the cache module, loosen the screws on the ECB cable and disconnect the battery cable from the cache module.
7. Disable the ECB by pressing the battery disable switch on the battery module front panel. See Figure 2-7.

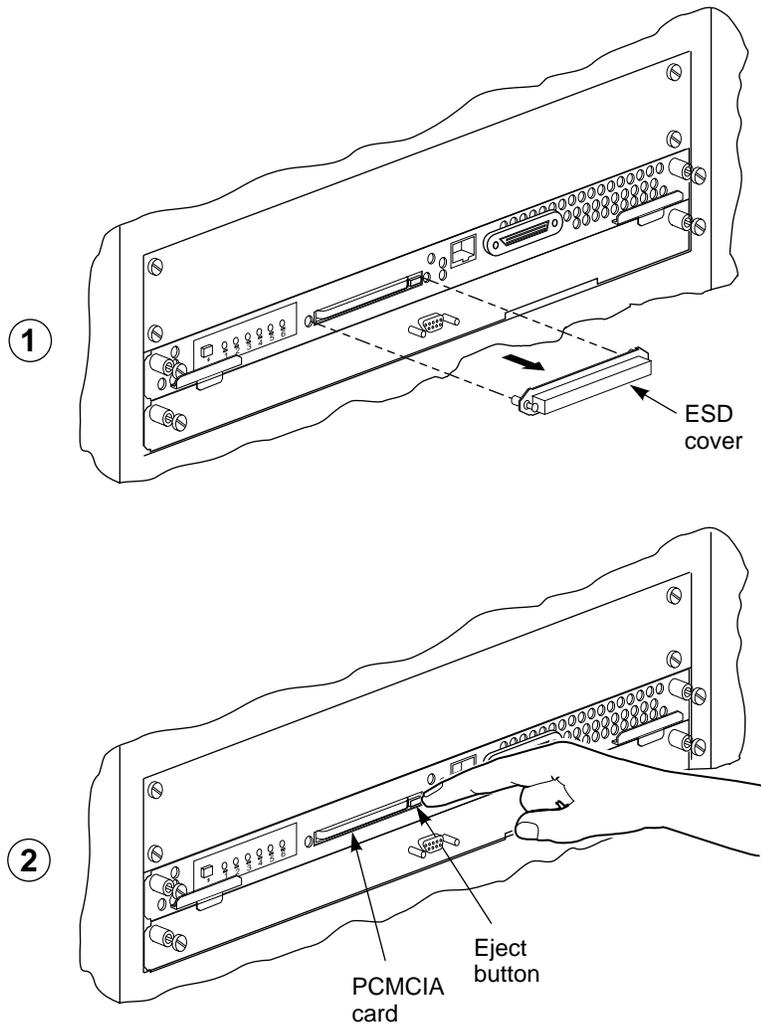
CXO-5302A-MC

3. Tighten the captive screws on the front bezel of both the controller and cache modules.
4. Reconnect the ECB cable to the cache module and tighten the mounting screws on the cable.
5. Reconnect the power cords to the controller power supplies.
6. Attach a maintenance terminal to the new controller.
7. Press and hold the controller's green reset (//) button, while inserting the program card. The program card eject button will extend when the card is fully inserted. See Figure 2-8.

Figure 2-8 Installing the program card

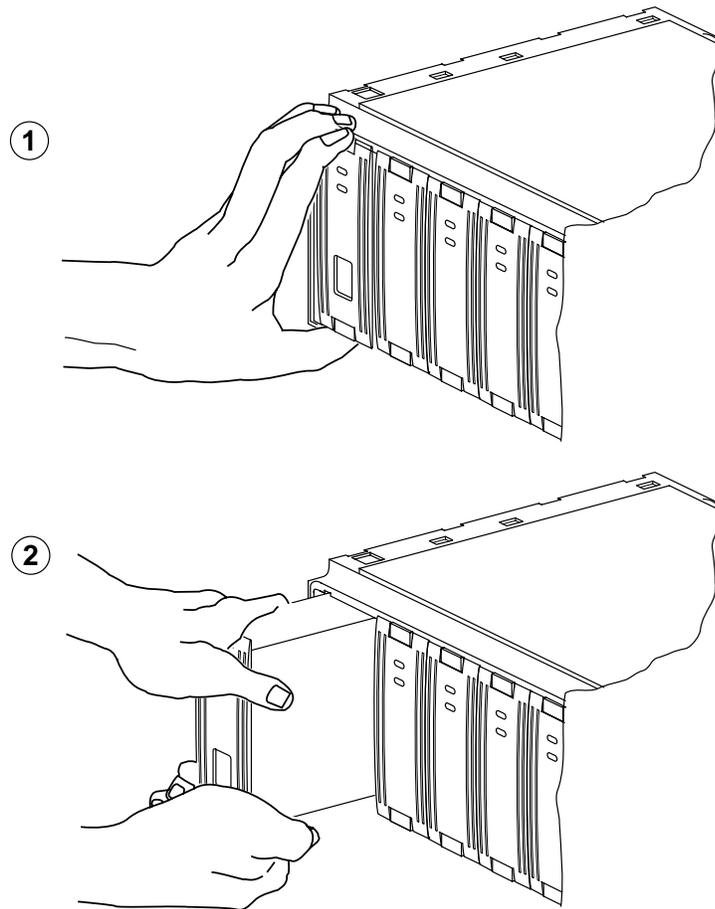
CXO-5228A-MC

4. Disconnect the power cords from the power supply.
5. Press the two mounting tabs together to release the power supply from the shelf and partially pull it out of the shelf. See Figure 2-9.
6. Use both hands to pull the power supply out of the shelf. See Figure 2-9.

**Figure 2-9 Removing the power supply**

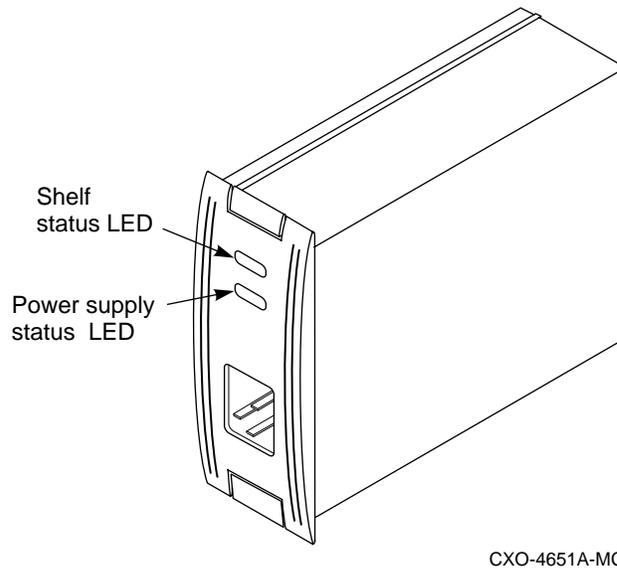
CXO-4651A-MC

3. Observe the power and shelf fault indicators to make sure they are on. See Figure 2-10.

**Figure 2-10 Power supply fault indicators**

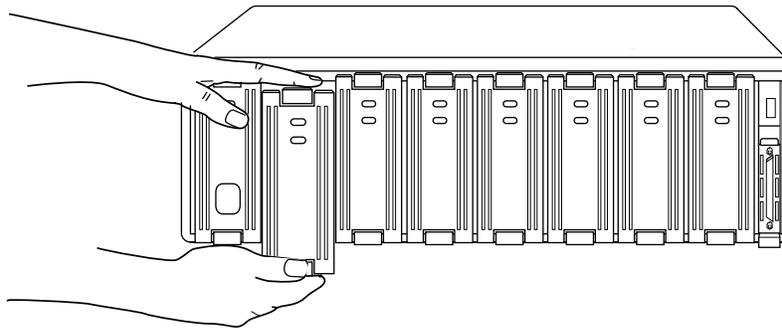
CXO-4439A-MC

5. If the failed device is part of a failedset, delete it from the failedset. If the failed device is part of a spareset, delete it from the spareset.
6. If the device is part of a storageset or unit, remove the device from the storageset or unit.
7. Once the device is no longer part of a storageset or unit, delete the disk name you determined in Step 3.
8. Determine which disk drive has failed using the procedures in Chapter 1, “Troubleshooting”, of this manual.
9. Press the two mounting tabs together to release the disk drive from the shelf and partially pull it out of the shelf. See Figure 2-11.

**Figure 2-11 Removing a disk drive**

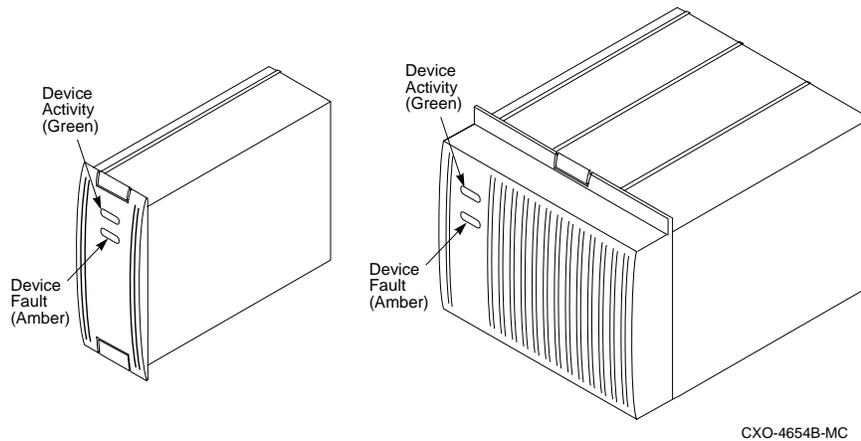
10. Using both hands, pull the disk drive out of the shelf.
11. Align the replacement disk drive with the shelf rails.
12. Push the disk drive all the way into the shelf until the locking tabs snap into place.
13. Observe the status LED for the following indications. See Figure 2-12.
  - The device activity (green) LED is either on, flashing, or off.
  - The device fault (amber) LED is off.

**Figure 2-12 Default indicators for 3.5- and 5.25-inch SBBs**

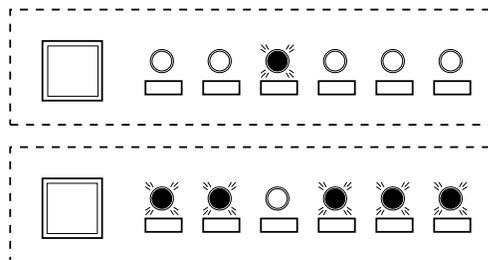
CXO-4824A-MC

1. Determine the failed device using the procedures in Chapter 1, “Troubleshooting”, of this manual.
2. Quiesce the port by pressing the OCP button for that port.
3. When the OCP LEDs flash in an alternating pattern the device port is quiesced. For example, when you quiesce device port three and I/O has halted, the OCP LEDs are flashing in an alternating pattern, as shown in Figure 2-13.

**Figure 2-13 OCP LED patterns**

4. At the replacement tape drive, press the two mounting tabs together to release the device from the shelf and partially pull it out of the shelf.
5. Use both hands to pull the device out of the shelf.
6. Quiesce the port again. Look for the OCP indicators depicted in the diagram in Step 3 of this procedure.
7. Align the replacement device with the shelf rails and insert the new device.
8. When the controller recognizes the device, the port light will be turned off and the system will return to normal operation.

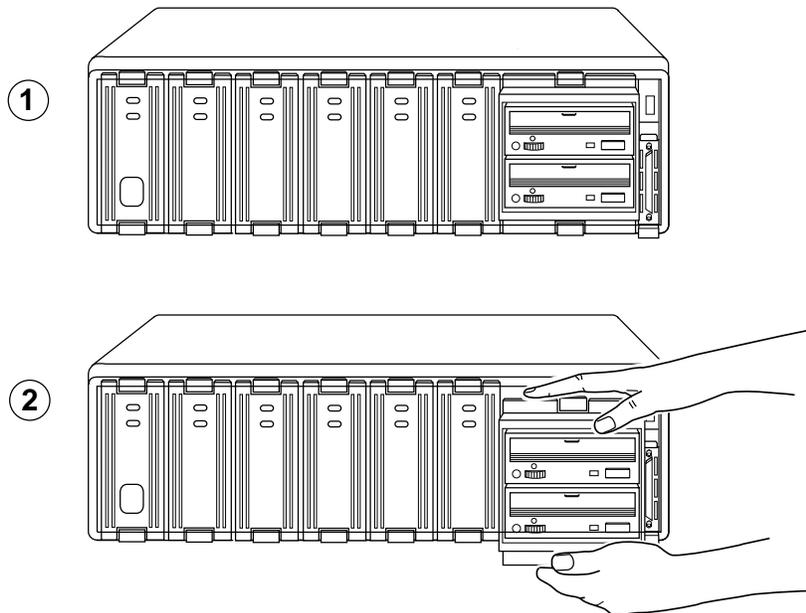
CXO-5229A-MC

5. Press the two mounting tabs together to remove the SBB from the shelf. See Figure 2-14.

**Figure 2-14 Removing the CD-ROM drive**

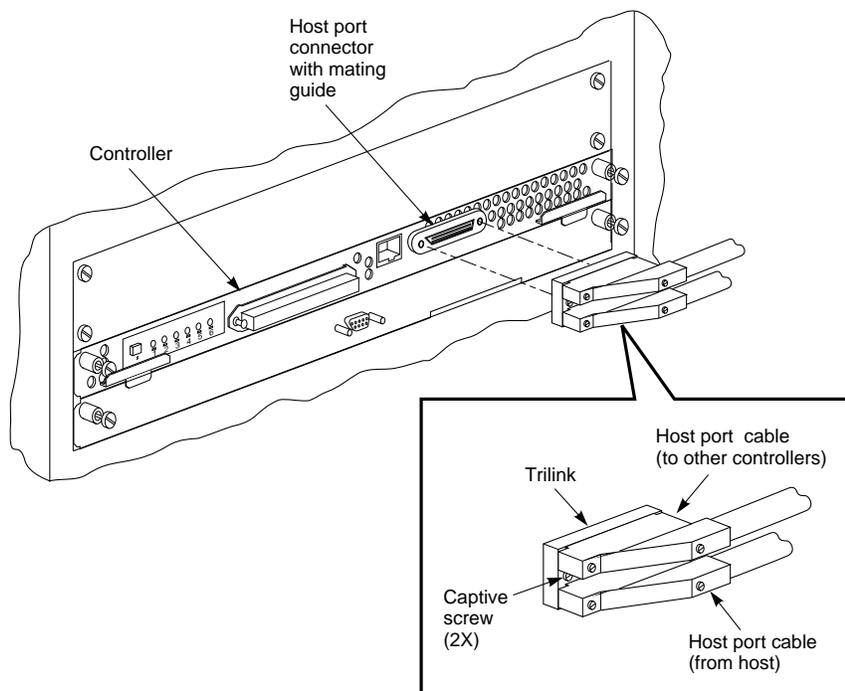
CXO-5298A-MC

1. Halt all I/O activity using the appropriate procedures for your operating system.
2. Dismount all units using the procedures for your operating system.
3. Disconnect the failed SCSI host cable from the host or other device.
4. Shut down the controller/controllers.
5. Loosen the captive screws on the trilink connector at the controller's front bezel. Disconnect the cable from the trilink connector. See Figure 2-15.

**Figure 2-15 Disconnecting the SCSI host cable**

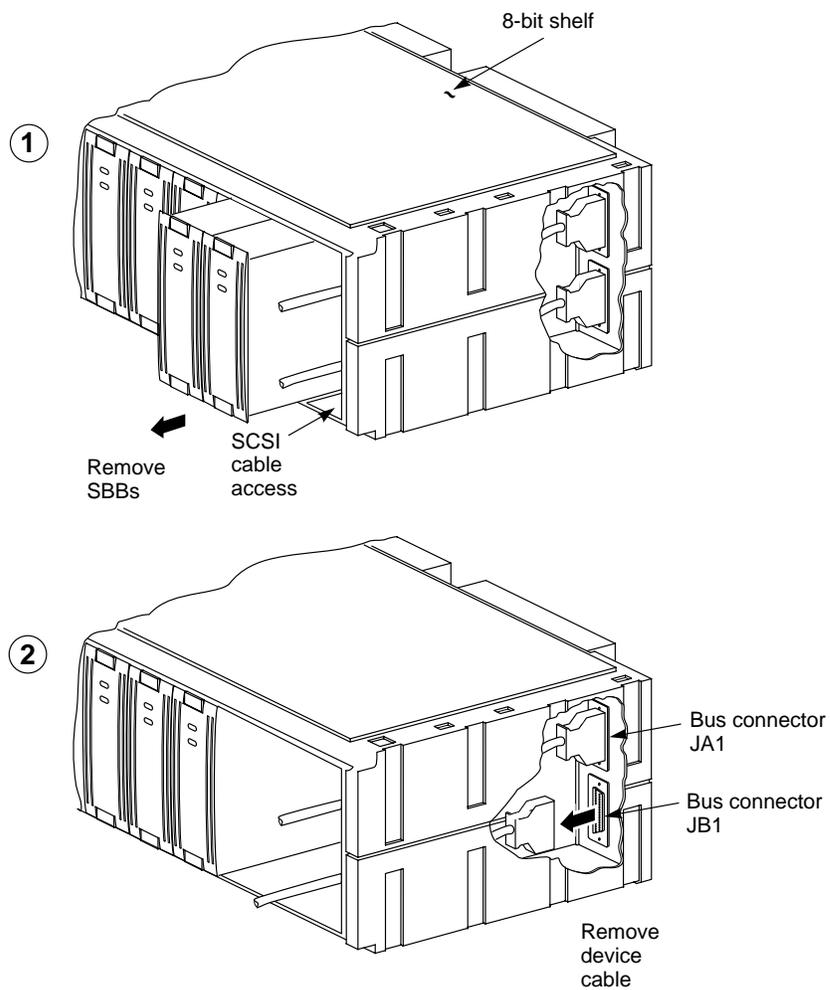
CXO-5176A-MC

- 5. Before removing the disk drives from the device shelf, let the drive spin down for at least 30 seconds. Gyroscopic motion from a spinning disk may cause you to drop and damage the disk.
- 6. Remove any SBBs necessary to gain access the SCSI cable. See Figure 2-17.

**Figure 2-17 Access to the SCSI cables**

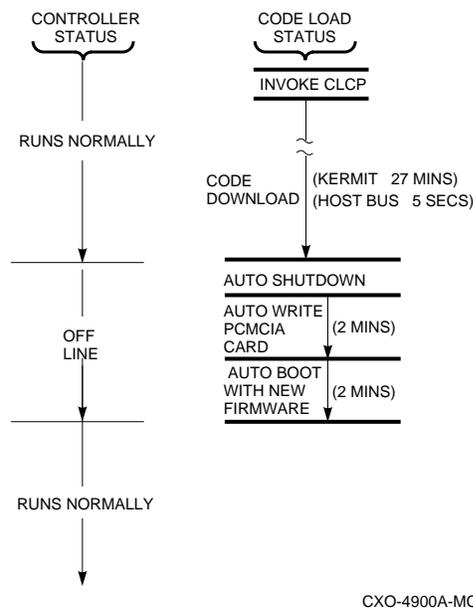
Figure 3-1 shows a flow diagram of the single controller code load method.

After the CLCP utility is invoked, the controller continues to run normally while the code is downloaded from host console or PC terminal program. This process may take from several seconds (for a host bus download) to 35 to 45 minutes (for a download performed via the maintenance terminal port). The only time the code load process interrupts device service is for a period of about 4 minutes, while the program card is written and the controller initializes with the new software.

**Figure 3-1 Single controller code load method**

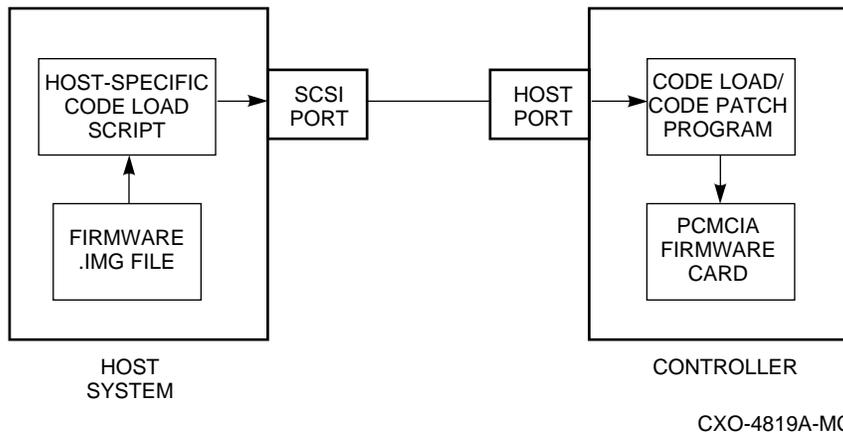
As shown in Figure 3-2, the user employs a download script running in the host to communicate with CLCP utility.

The user invokes the CLCP utility via the CLI, and when prompted, instructs the host to download the binary software image to the controller using the download script. The controller rewrites the software in its program card using the downloaded software image.

**Figure 3-2 Host port code load operation**

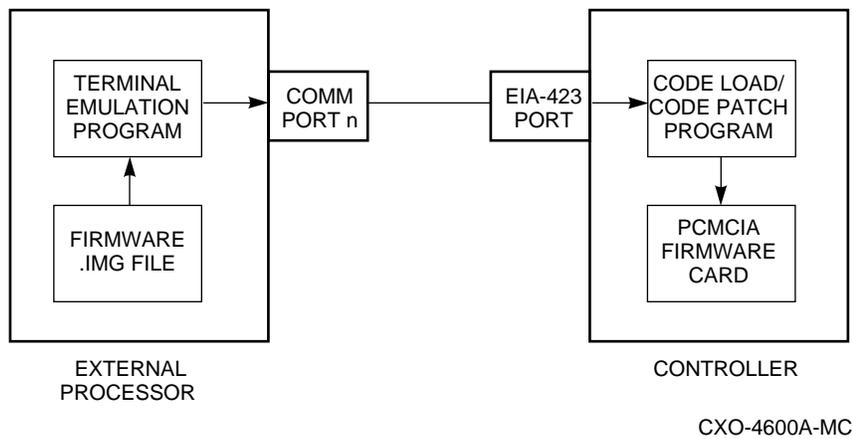
As shown in Figure 3-4, an external processor containing a binary image of the controller software is connected to the controller's maintenance port. The external processor is typically a personal computer (PC). The user employs a terminal emulation program running in the external processor to communicate with the CLI in the controller. The user invokes the CLCP utility via the CLI.

When prompted by the CLCP utility, the user instructs the terminal emulator program to download the binary software image to the controller using the KERMIT line protocol. The controller rewrites the software in its program card using the downloaded software image.

**Figure 3-4 Terminal port code load operation**

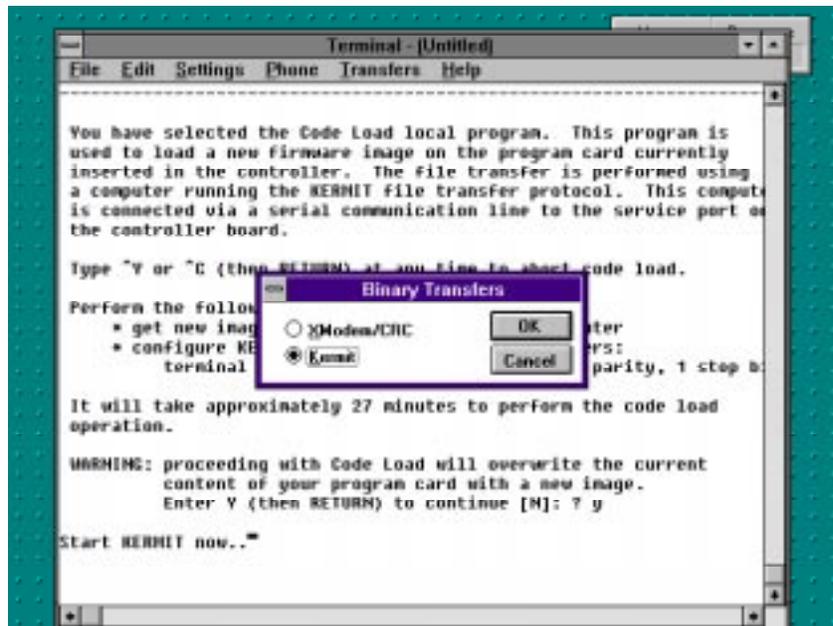
**Figure 3-5 Binary transfer protocol selection**

10. Select the KERMIT transfer protocol and click on the OK button. See Figure 3-5.
11. Your external processor and the serial link to the controller are now ready to download the new software image to the controller.
12. Remove the program card ESD cover.

- Stop Bits 1
  - Parity None
  - Flow Control Xon/Xoff
8. Press the Enter key to obtain a CLI prompt. The controller should respond with a prompt such as “HSZ50”. If it does not respond, check your communications connection and terminal emulator configuration. Make sure the emulator and CLI communications settings match.
  9. Open the Settings menu on the terminal emulator menu bar and select the Binary Transfers option. The binary transfers protocol selection menu is displayed.

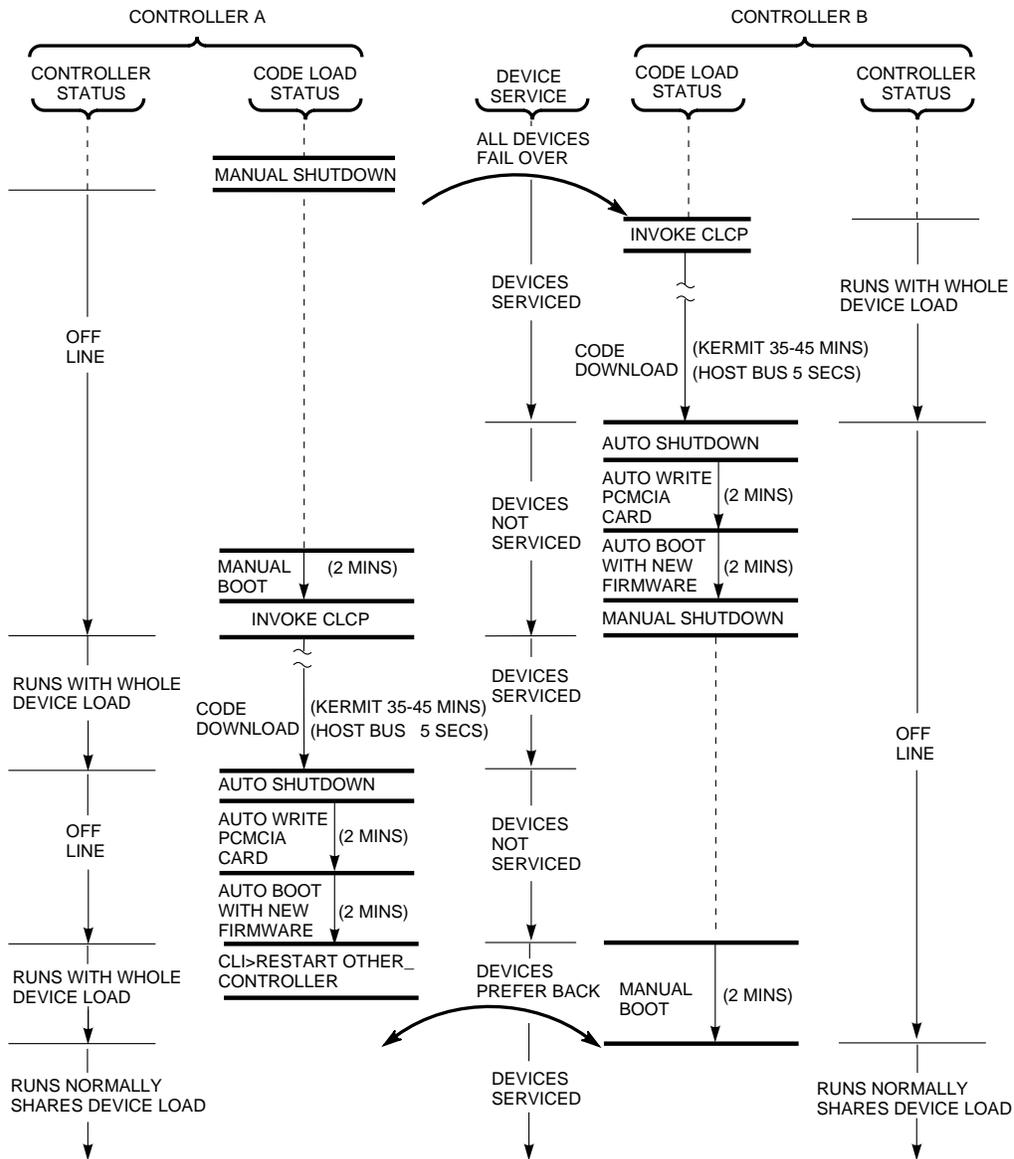
CXO-4926A-MC

The sequential upgrade code load method for dual-redundant configurations is illustrated in Figure 3-6. This method is *required* for major software upgrades.

The sequential upgrade method forces an interruption to device service. To avoid a situation in which the two controllers are running different software versions, each is shut down, while the other is code loaded. As shown in Figure 3-6, there are two periods of time when both controllers are off line. During these periods, devices are not serviced, and the subsystem is off line. I/O activity also should be halted during the code load operation.

Figure 3-6 The sequential upgrade method

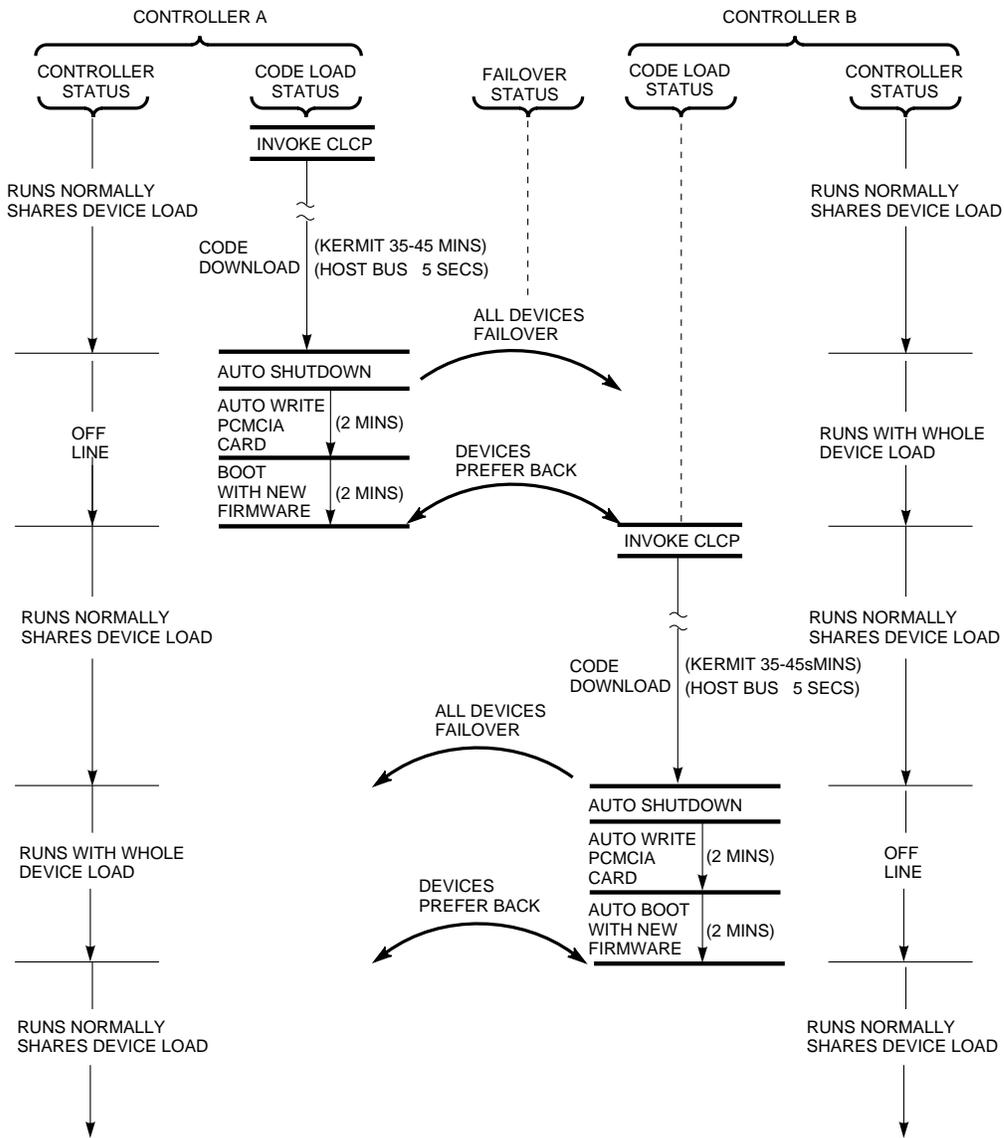
CXO-4901A-MC

Figure 3-7 The concurrent upgrade method

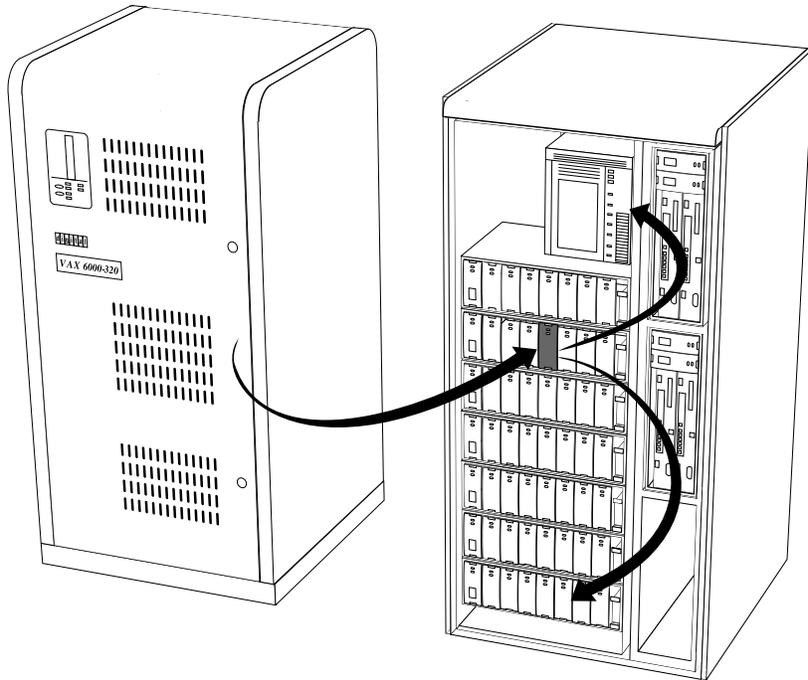
CXO-5259A-MC

Installing new firmware on a disk or tape drive is a two-step process as shown in Figure 3-8. First, copy the new firmware from your host to a disk drive in your subsystem, then use HSUTIL to distribute the *firmware* devices in your subsystem.

**Figure 3-8** Installing new firmware on a disk or tape drive

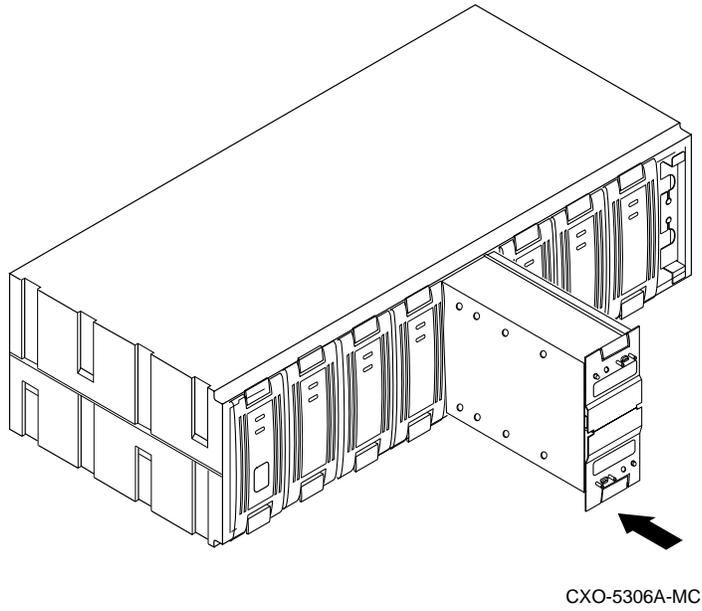
2. Connect a maintenance terminal to the controller.
3. Install an external cache battery SBB into a convenient device slot. See Figure 3-9.
4. Install the controller power supplies into the controller shelf. See Figure 3-10.

**Figure 3-9 Installing an SBB battery module**

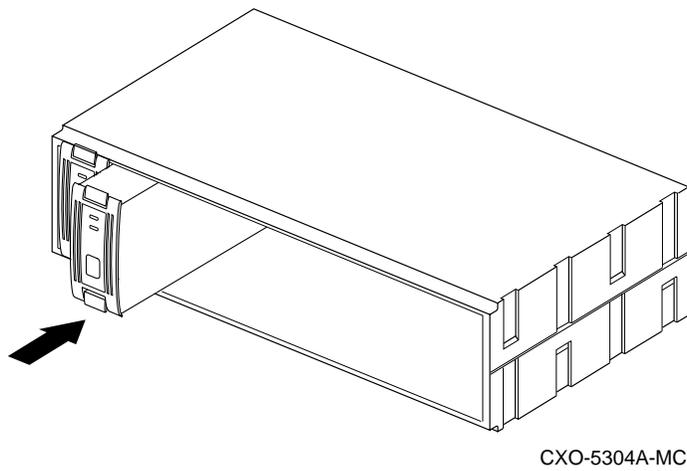
**Figure 3-10 Installing controller power supplies**

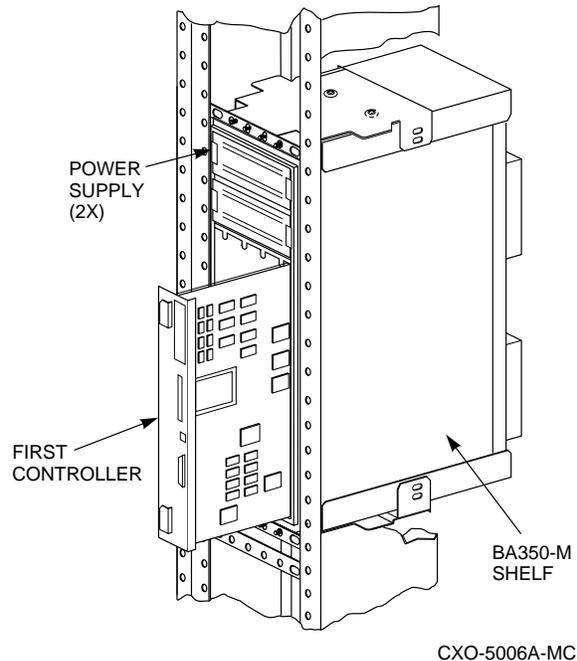
**Figure 3-11 Installing a single controller (SW800 cabinet)**

5. Slide the cache module into the appropriate slot in the controller shelf with a gentle rocking motion to help seat the module.
6. Install the controller module into the shelf slot that corresponds to SCSI ID 7. See Figure 3-11.

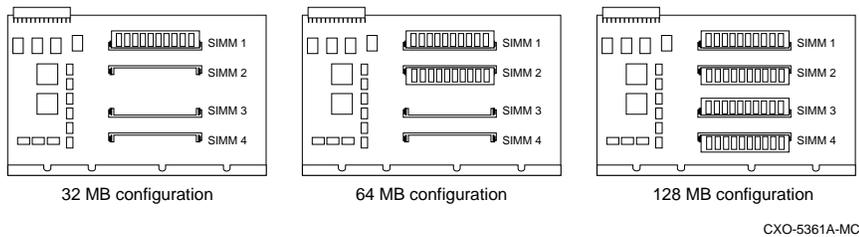
**Figure 3-12 Cache configurations for cache Version 3**

The cache board is marked by SIMM slot numbers as shown in Table 3-4.

9. Loosen the captive screws on front bezel of both cache modules.
10. Loosen the cache modules from the shelf using a gentle rocking motion and slide the cache modules from the controller shelf.
11. Refer to Table 3-4 and Figure 3-12 and install as many SIMM cards into each cache modules as required.

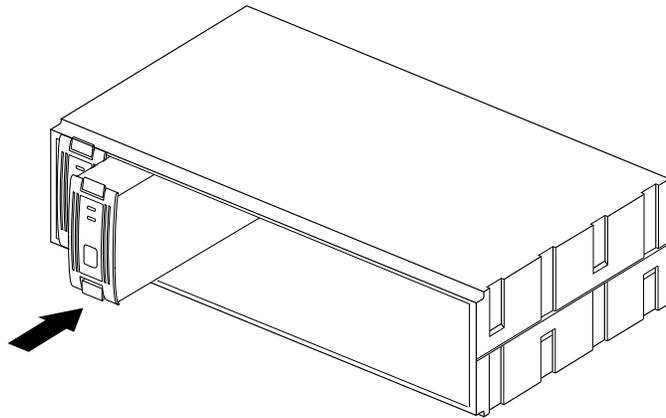
**Figure 3-13** Installing a power supply

1. Orient the power supply so that the status indicators are at the top. Firmly push the power supply into the shelf until the mounting tabs snap into place. See Figure 3-13.

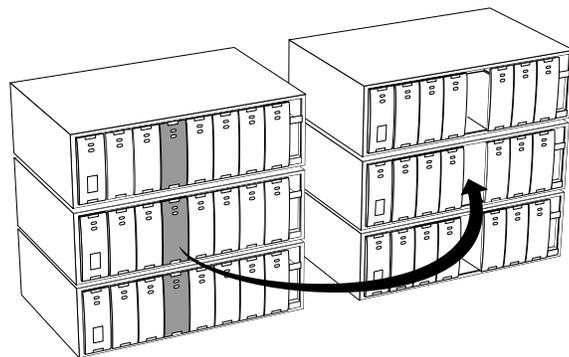
**Figure 4-1 Moving a storage set from one subsystem to another**

You can move a storage set from one subsystem to another without destroying its data. You also can follow these steps to move a storage set to a new location within the same subsystem. See Figure 4-1.

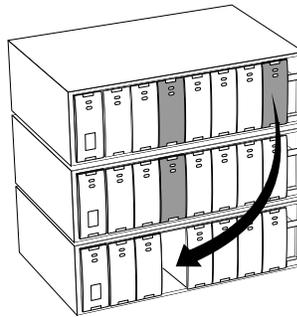
**Figure 4-2 Moving storageset members**

You may want to move a storageset member and its data from one PTL location to another to maintain the symmetry in your subsystem. For example, if a RAIDset member fails and is replaced by a disk drive in the spareset, you could move the replacement member into the column that contains the RAIDset. See Figure 4-2.

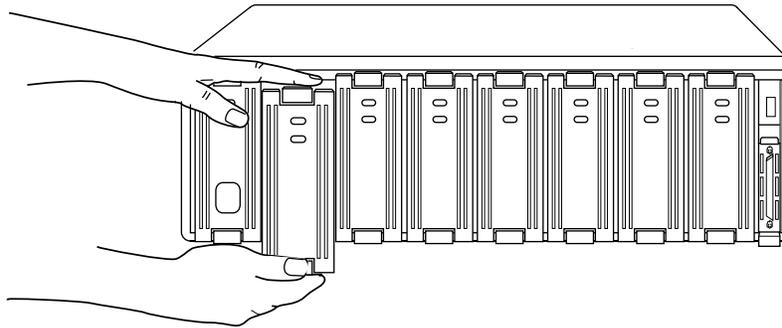
**Figure 5-1 Removing a 3.5-inch disk drive**

```
HSZ50> DELETE disk-name
```
4. Halt all I/O activity to the disk drive using the appropriate procedures for your operating system.
5. Press the two mounting tabs together to release the disk drive from the shelf and partially pull the disk drive out of the shelf. Allow the disk drive to spin down. See Figure 5-1.

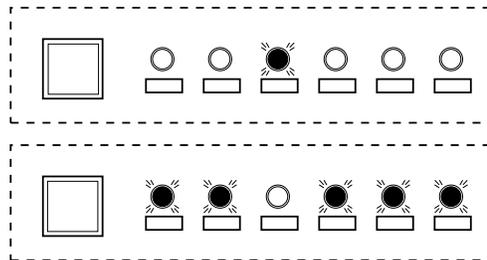
**Figure 5-2 OCP LED patterns**

1. Halt all I/O activity to the tape drive using the appropriate procedures for your operating system.
2. Quiesce the appropriate device port by pushing the device port button on the controller's OCP (operator control panel).
3. When the OCP LEDs flash in an alternating pattern the device port is quiesced. For example when you quiesce device port 3 and I/O has halted, the OCP LEDs are flashing in an alternating pattern as shown in Figure 5-2.
